**THE SOUTH PACIFIC ISLANDS EARTHQUAKE AND TSUNAMI  
OF 29<sup>TH</sup> SEPTEMBER 2009**

**A PRELIMINARY FIELD REPORT BY EEFIT**

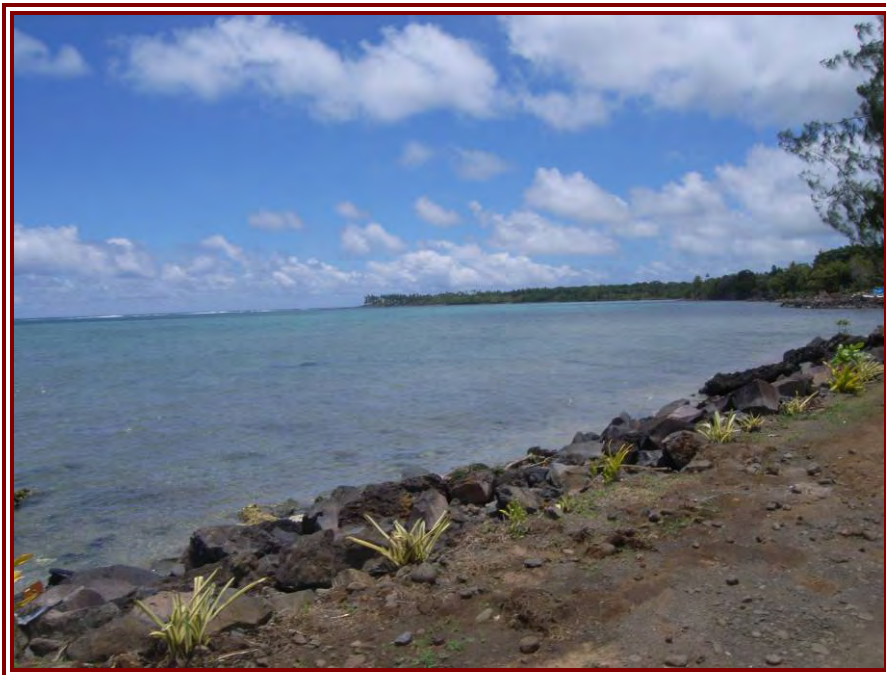
**Figure 5: A seawall found at Satoa made up of various volcanic rocks and mortar lined the coast**

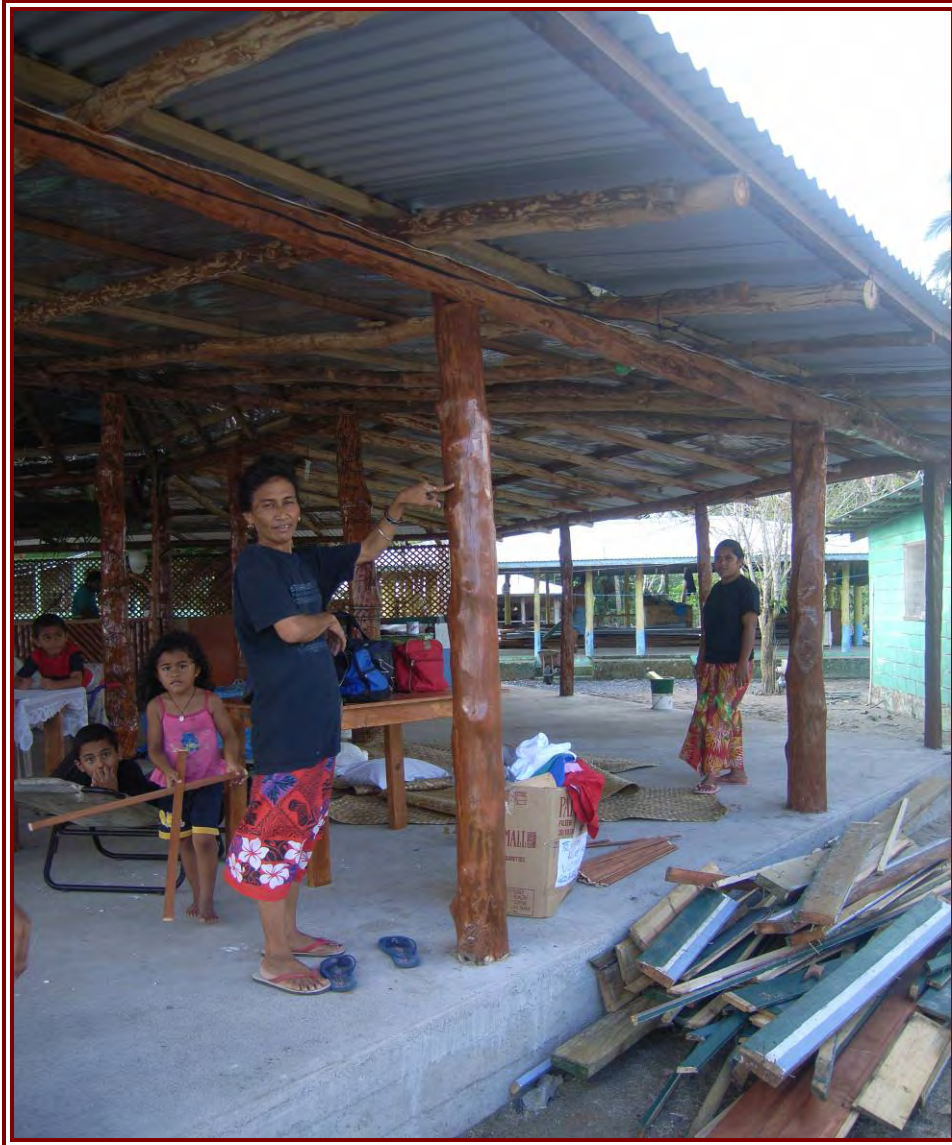
Figure 8: Tsunami wave height at this fale's location in Tafitoala was around 1.85m, as shown by the local resident

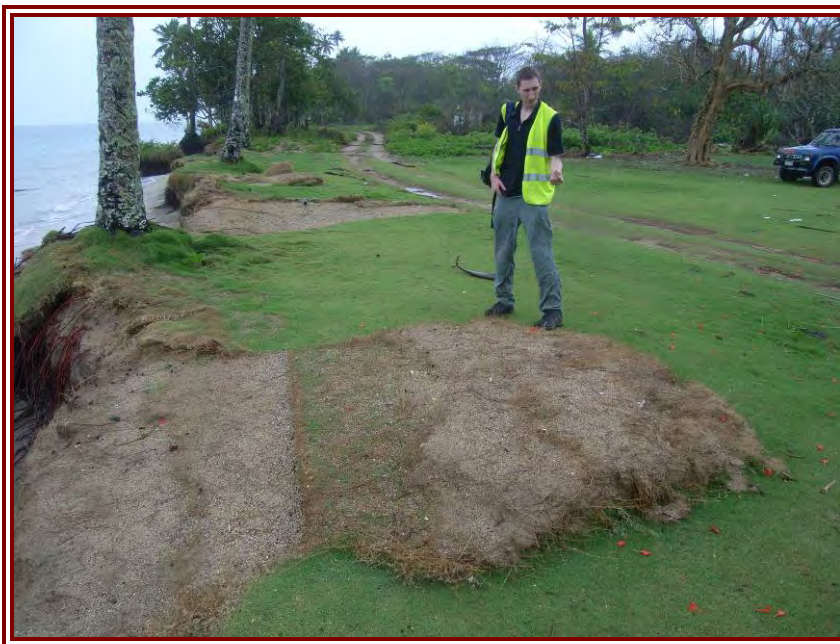
**Figure 9: Large turfs of grass undercut by the wave and lifted in one large mat (2x2mx10cm deep) were evident at Mulivai**

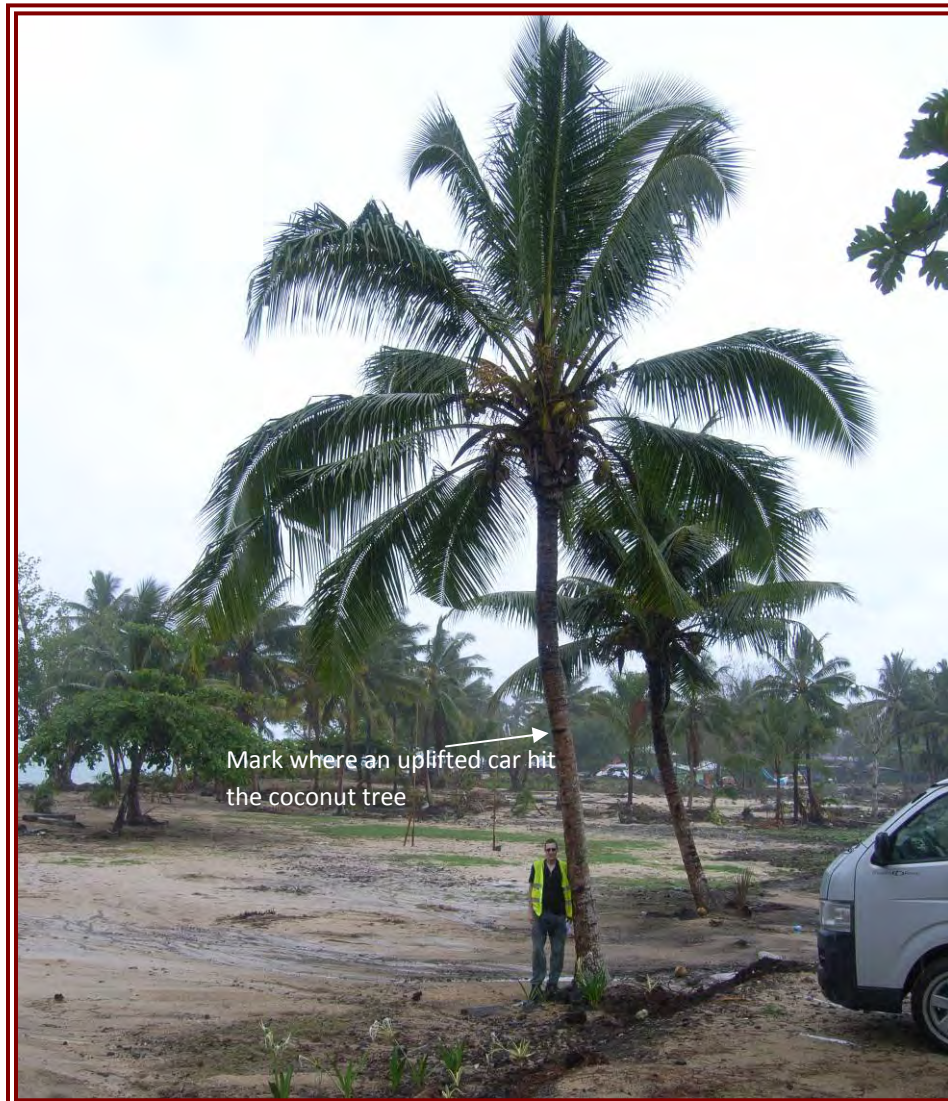
**Figure 11: The mark left by floating debris on a coconut tree gives an indication of the force and height of the water at Maninoa**

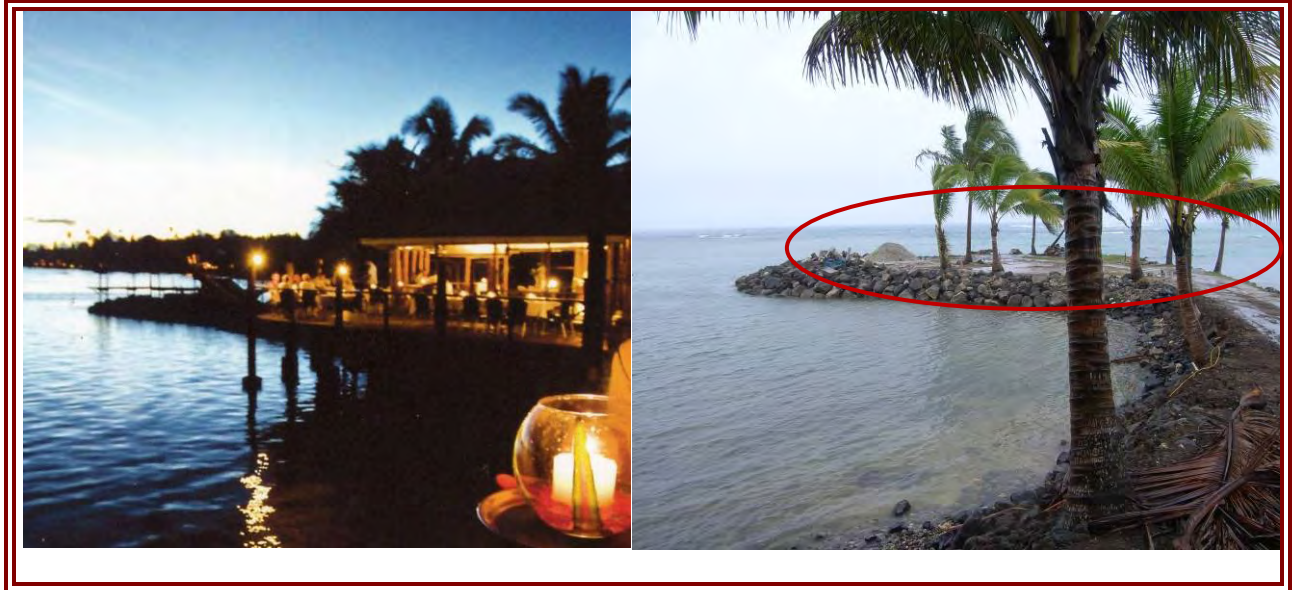
**Figure 13: A picture of the beach bar restaurant at the Sinaiei Reef Resort before and after the tsunami**

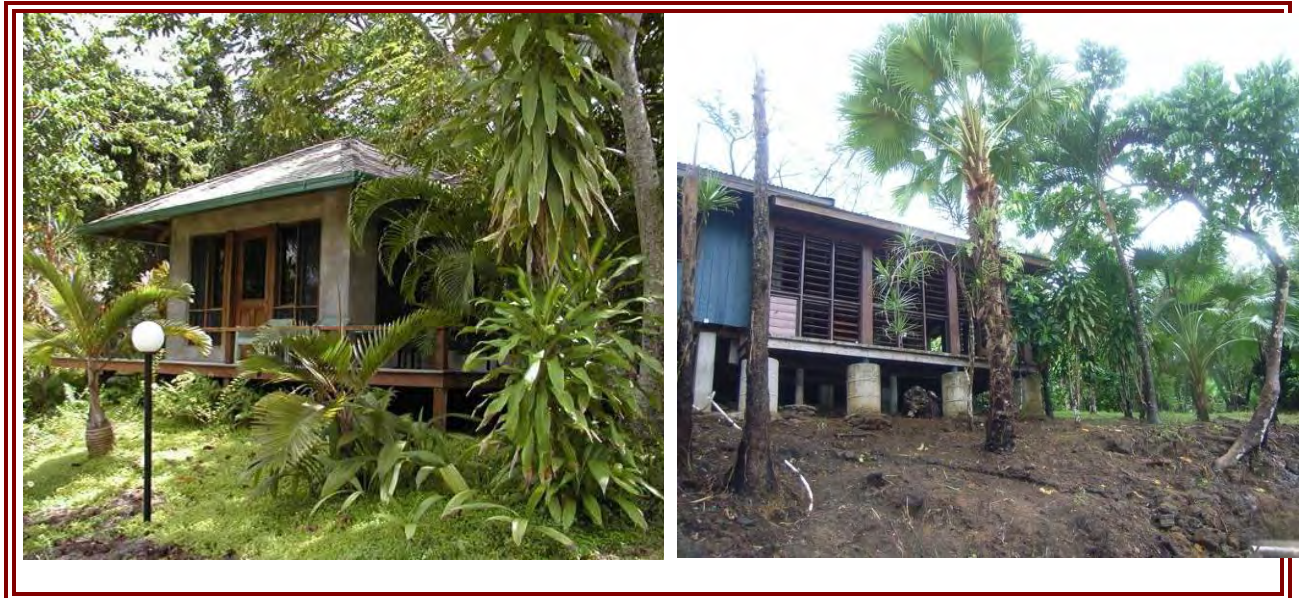
All of the beachfront fales were completely destroyed. These were closed fales made of timber. The honeymoon suite jacuzzi (concrete structure), located right by the coast, was intact with no structural damage but the decking around the structure and the accompanying fale were completely washed away. Alongside the path behind the row of beachfront fales, the tsunami wave had eroded a steep, densely-vegetated slope, exposing pillar foundations of fales some 6m above sea level as shown in Figure 14.

**Figure 14: Photo taken from the [www.preferencetravel.co.uk](http://www.preferencetravel.co.uk) website of the Sinaeli Reef Resort of the dense forested area before the tsunami (left) and the same location with exposed foundations after (right)**

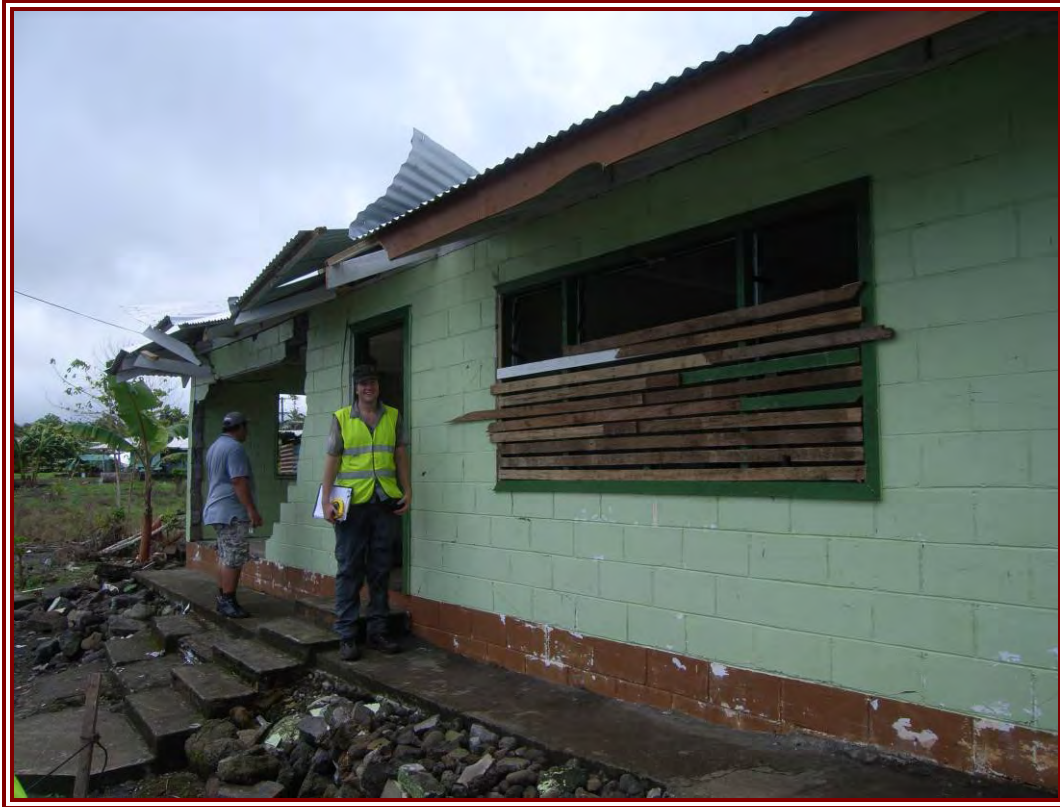
**Figure 16: This reinforced concrete frame house built in 2007 had damage to the front and back infill walls. All partition walls inside was also damaged, although the structure remained standing.**

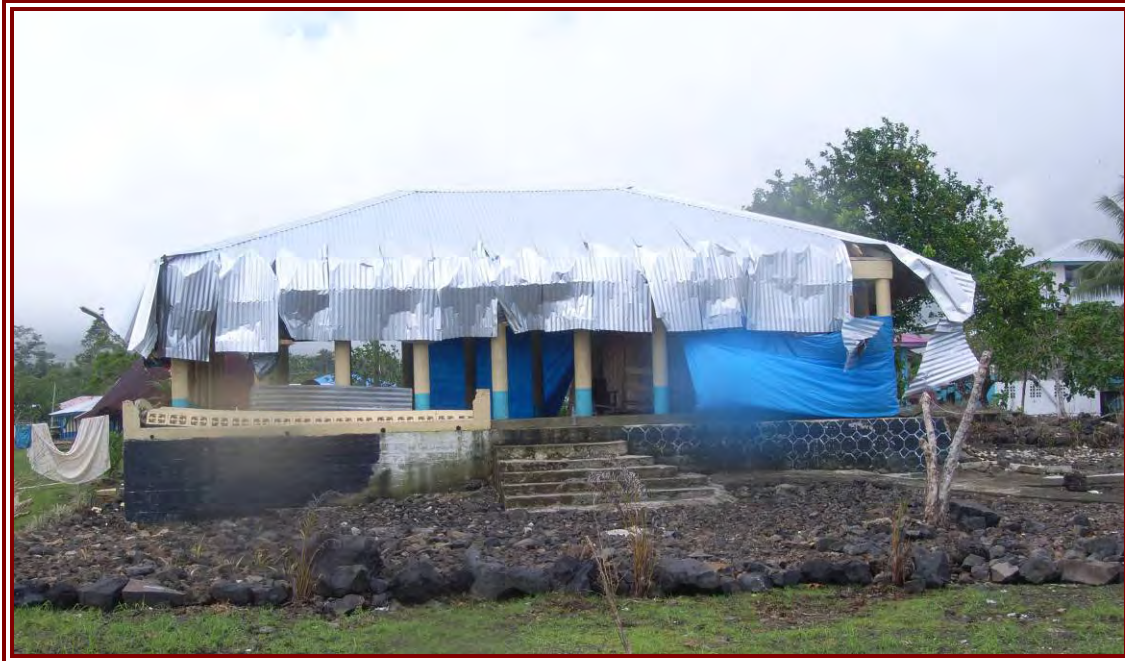
The house shown in Figure 17 would suggest the wave may have impacted from above as the corrugated iron roof had been bent downwards, at some 4m from the ground, 20m inland.

**Figure 17: This photograph would suggest the wave may have impacted from above as the corrugated iron roof was bent downwards**

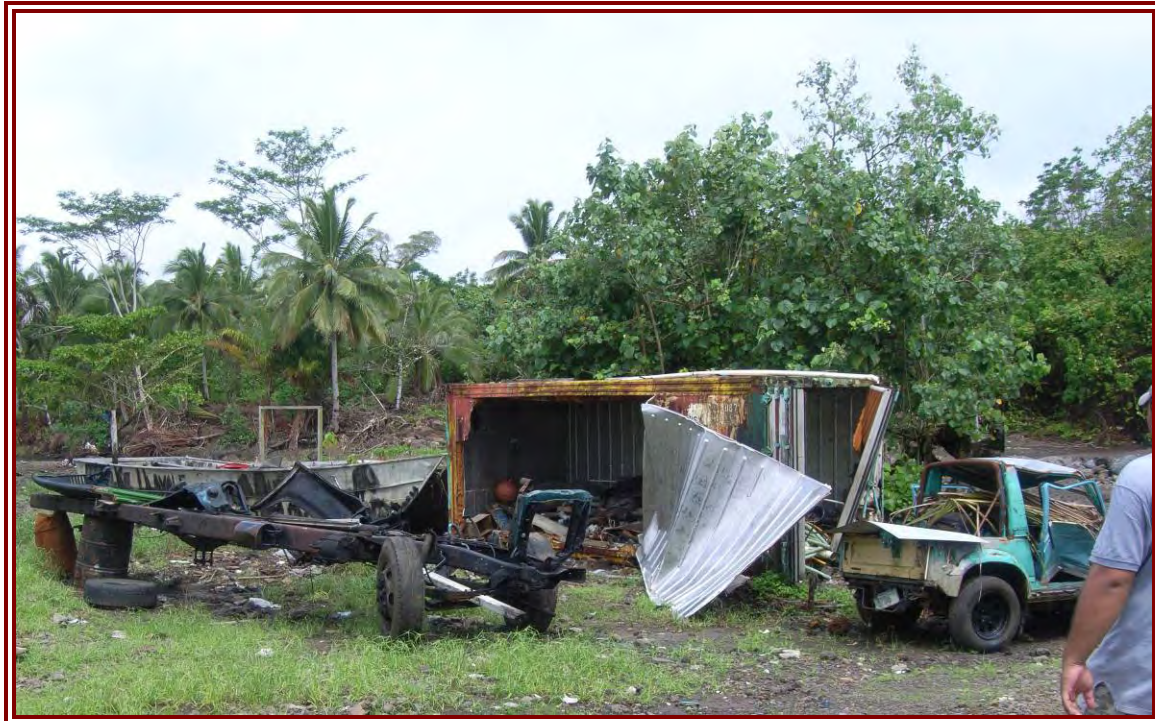
An idle metal shipping container which was closed at the time of the tsunami was also said to have ripped open by the waves and a Suzuki car was also lifted and carried 57m inland.

**Figure 18:** Residents at Si’umu-sisifo recounted how this metal container was “ripped open” by the wave

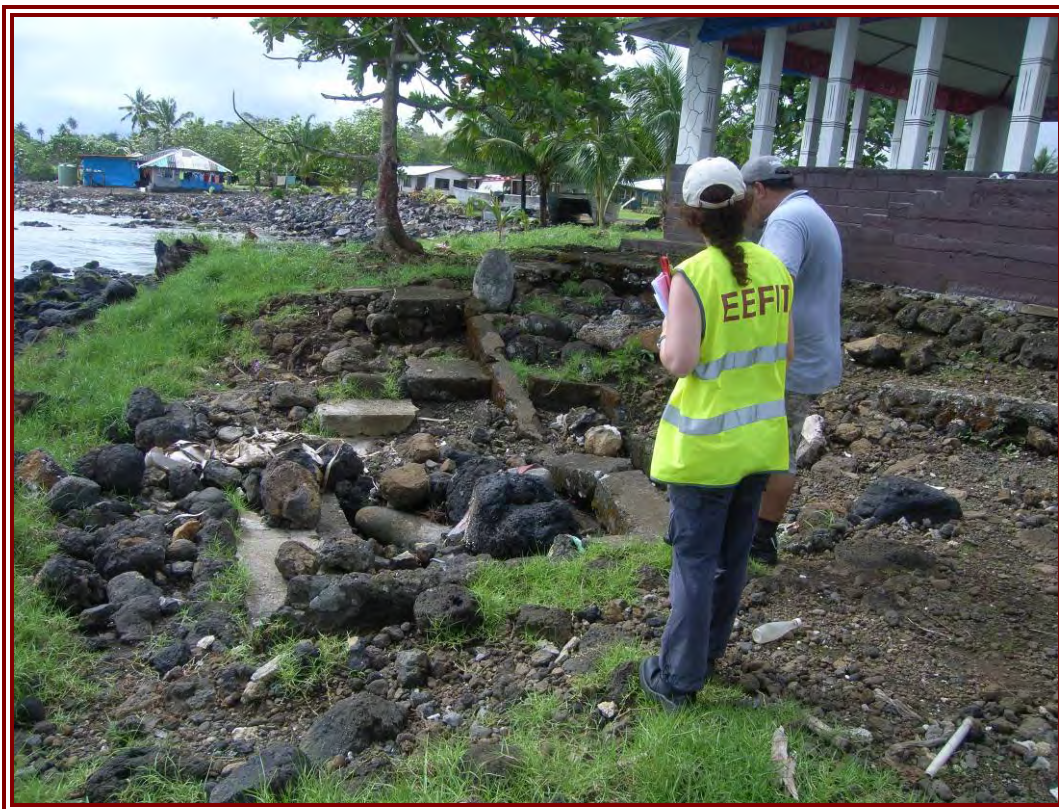
**Figure 19: A natural spring at Siumu-sasa'e was blocked by debris brought inland by the tsunami**

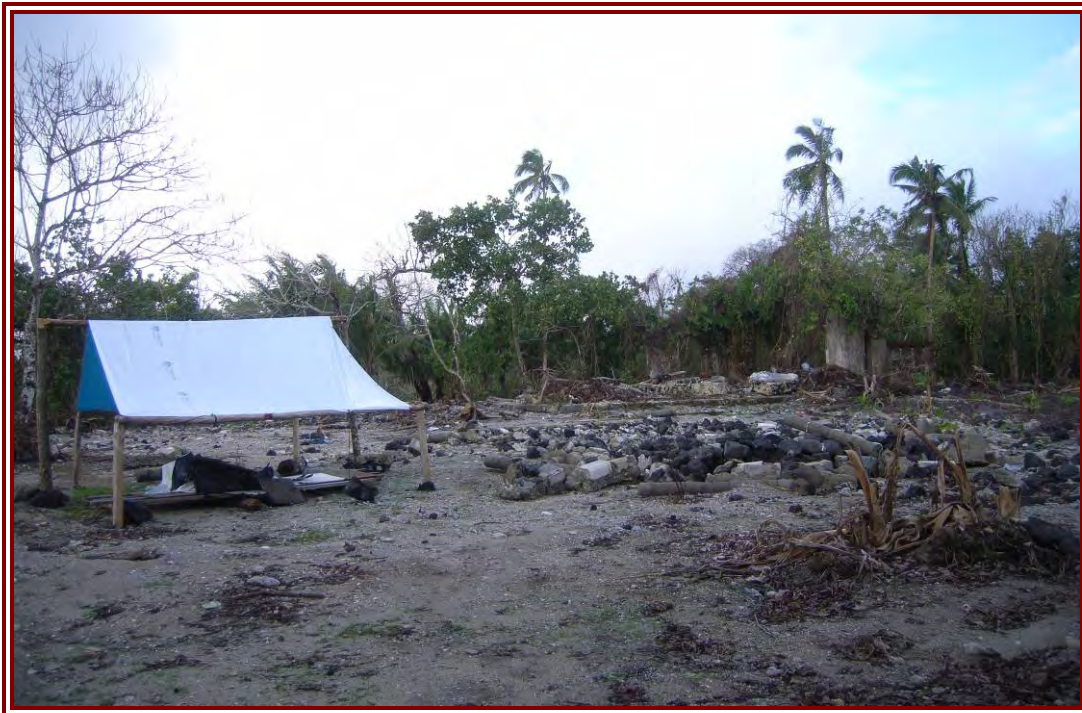
**Figure 20: A photograph showing the water inundation and devastation left at Sa'aga-fou**

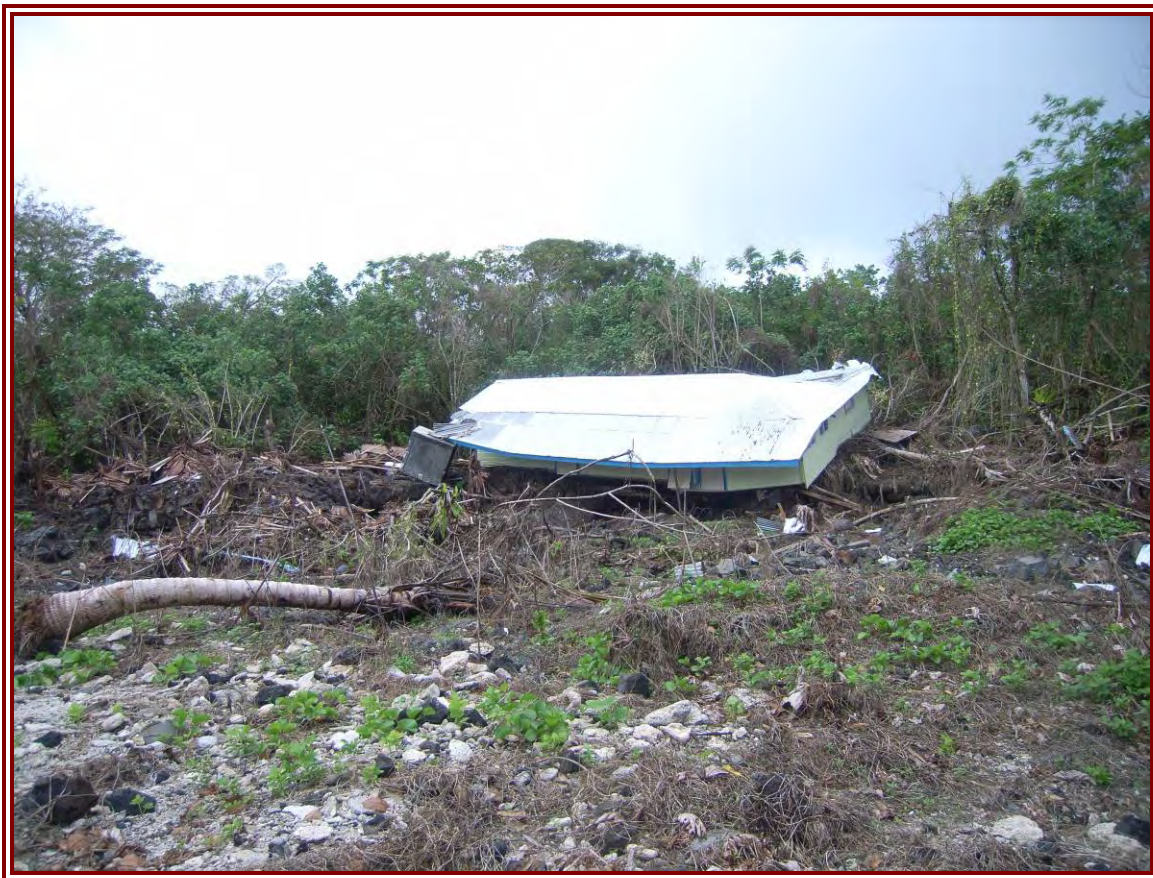
The timber walled house with a corrugated iron roof as shown in Figure 21 belonged to a local family who had this house and fales in front as a holiday rental business. The location had a natural rocky (lava outcrop) shoreline and the inundation distance from the shore was measured at 70m. From the remains of the concrete steps and foundation base, it can be inferred that the house had been lifted and carried 50m inland, stopped in its path only by the trees behind.

**Figure 21: A photograph showing a timber house carried inland some 50m by the tsunami at Sa'aga-fou**

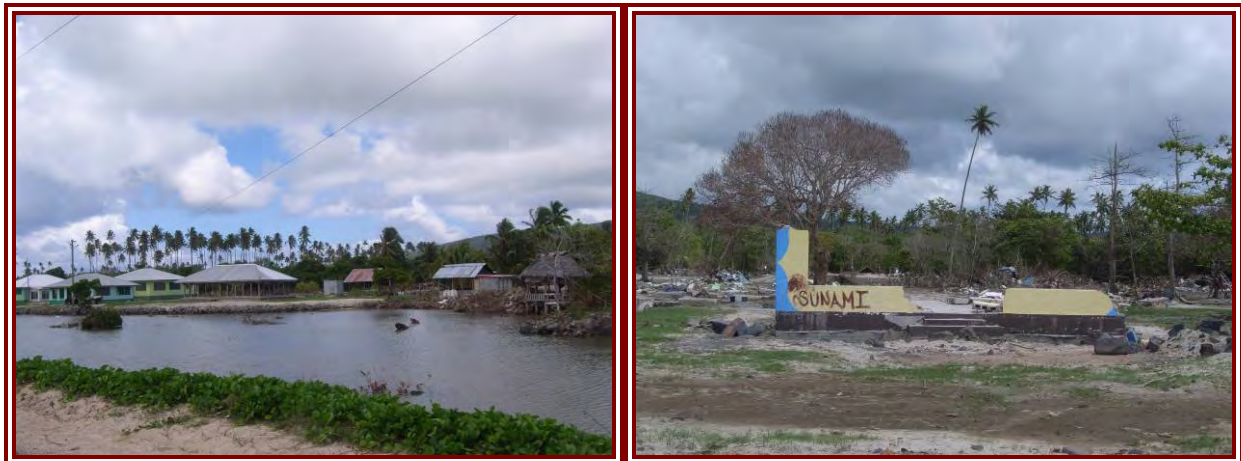
**Figure 25: Photographs showing the difference in damage between the village of Lotopue (left) and Malaele (right), which was not protected by the lagoon**

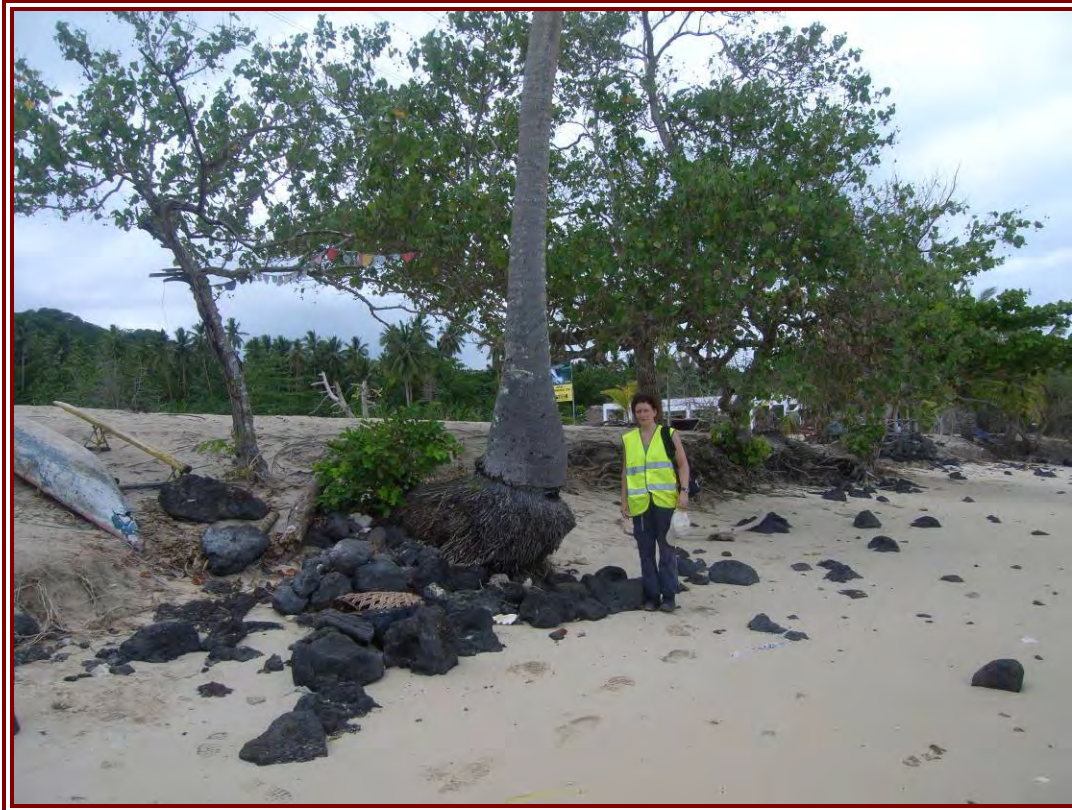
up to 4-5m of beach has been lost and where sand had been covering rocks, these are now exposed though the erosion observed is not consistent along the shore.

**Figure 27: Photograph taken at Apai showing the erosion of the coast caused by the tsunami**

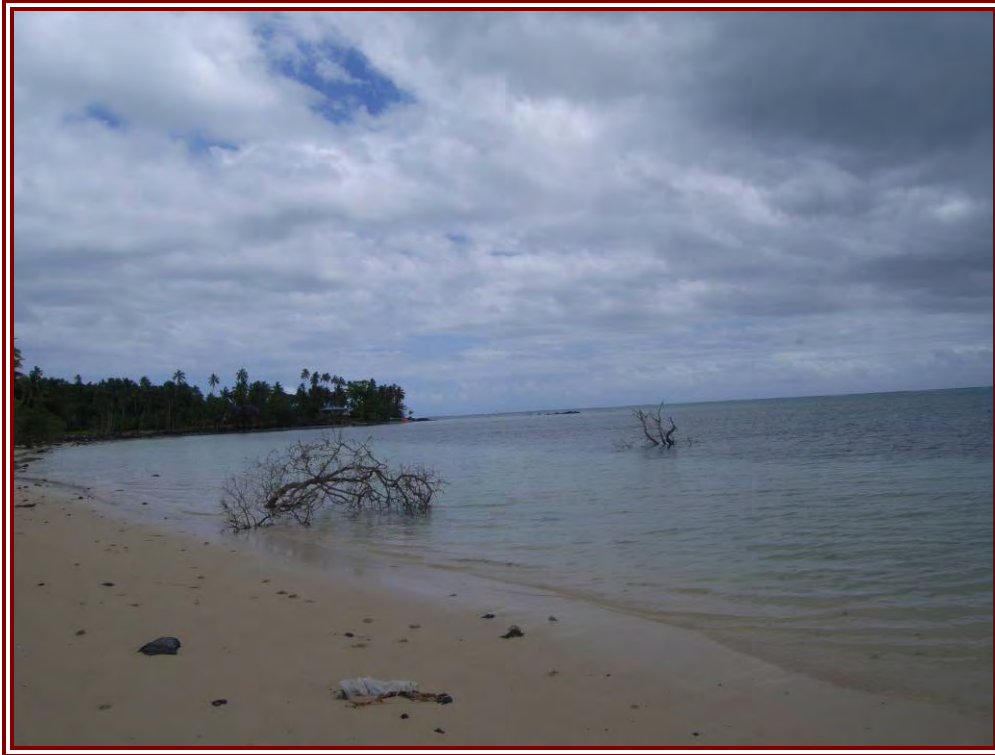
**Figure 28: Photograph taken at Apai showing the uprooted trees in the lagoon**

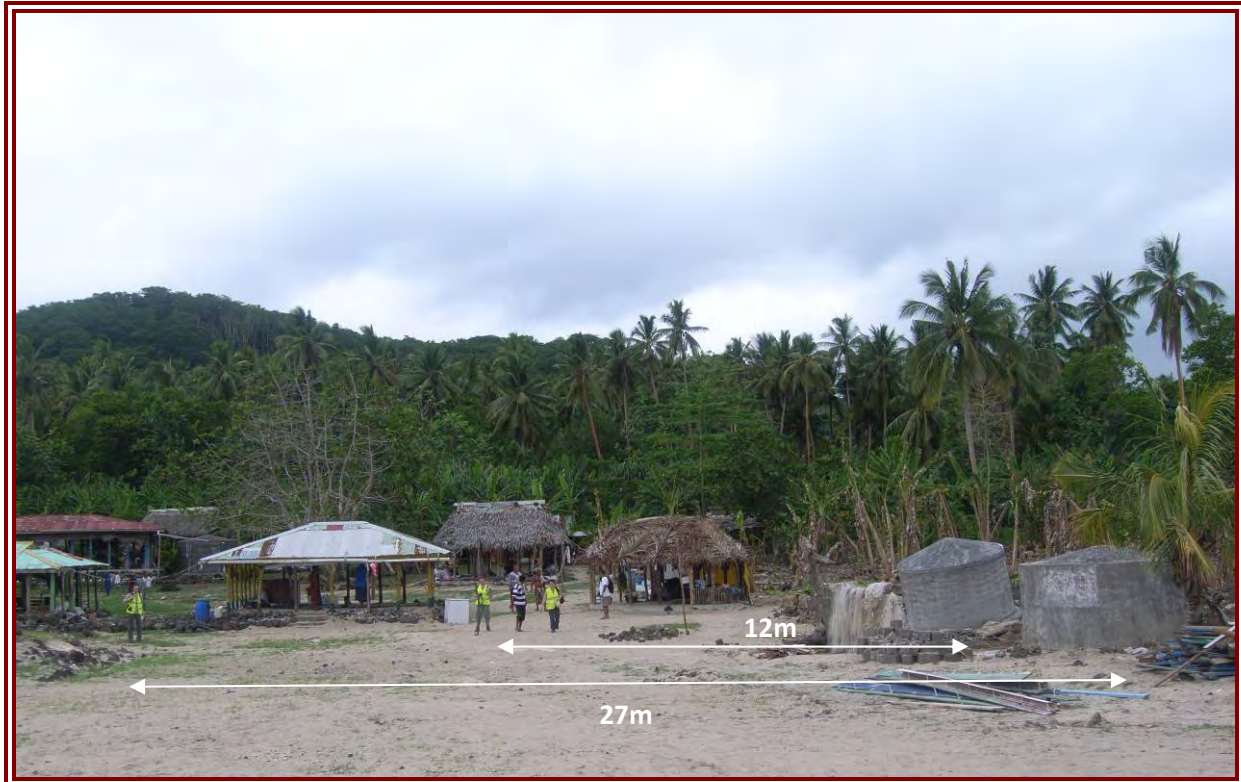
**Figure 29: Two water tanks moved were lifted from their very thin concrete screed foundations 12m and 27m respectively**

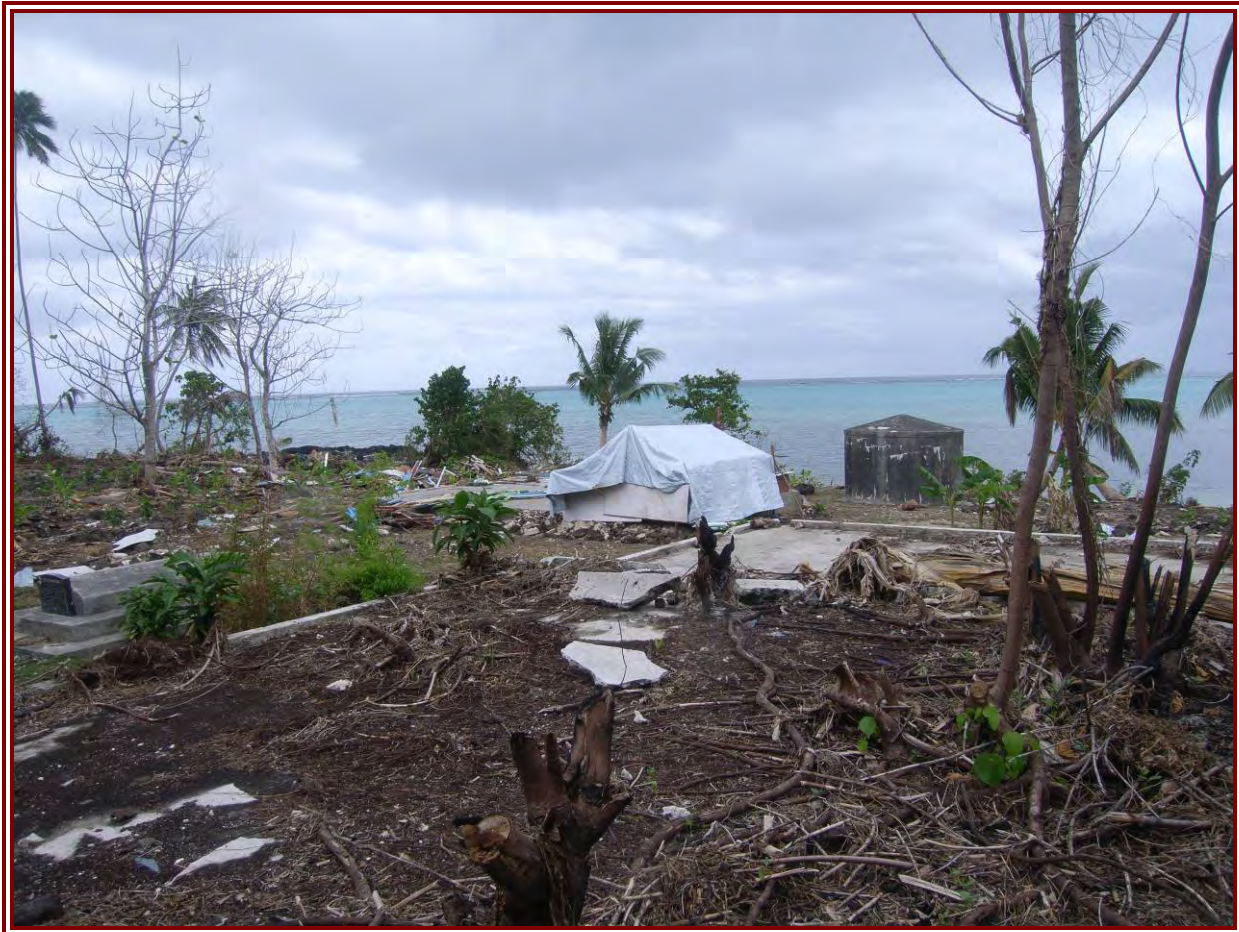
**Figure 30: The remains of a timber fale at the village of Lepuia'i completely destroyed by the tsunami wave; only the concrete base foundation remains.**

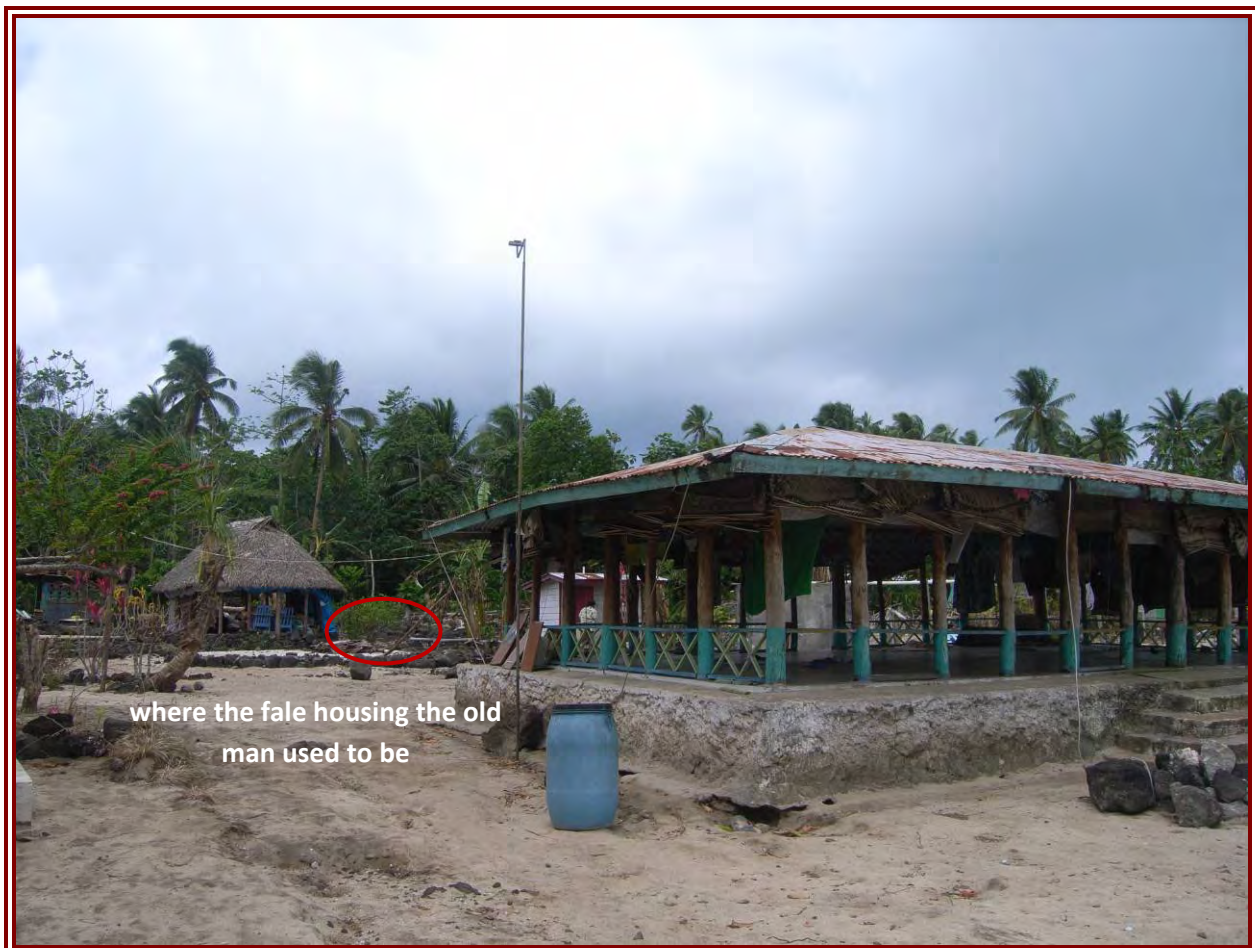
**Figure 31: The set of fale at Lepuia'i where the front open fale prevented the old faleoo in the middle from being washed out to sea by the backwash of the waves**

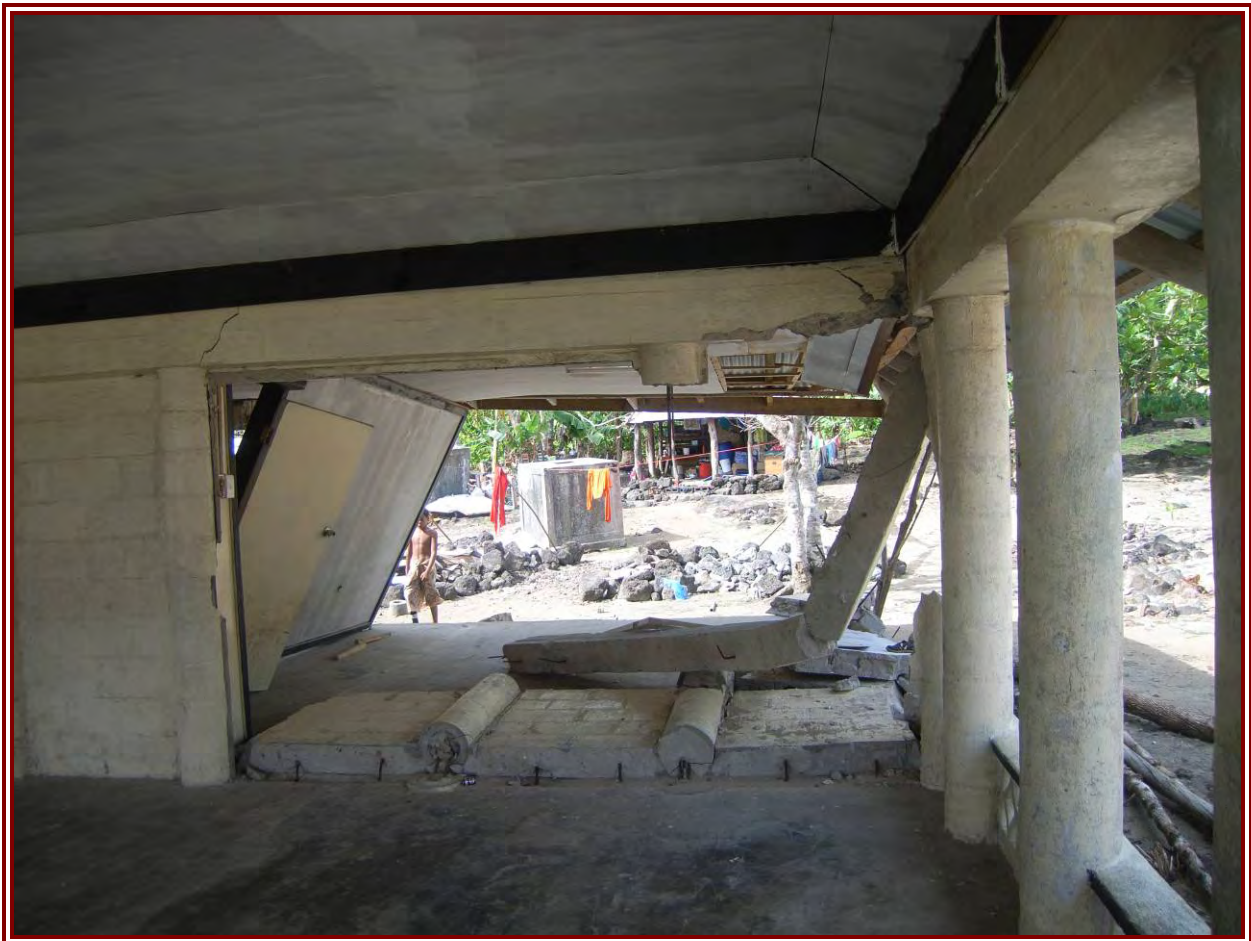
**Figure 32: Damage to the weakly reinforced concrete columns and infill walls of a house at Lepuia'i**

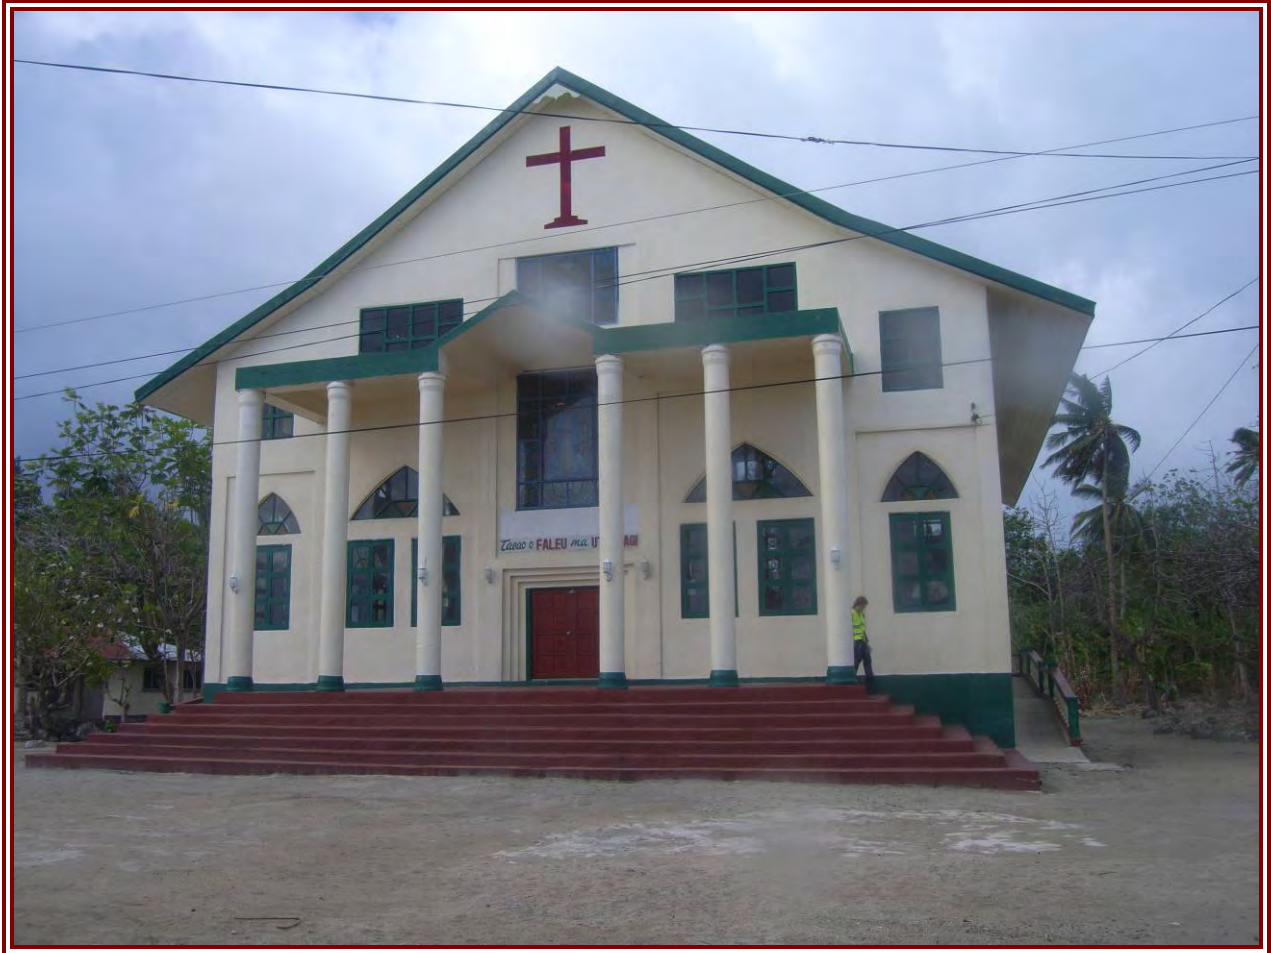
At the elevated church shown in Figure 33, which was located 30m from the coast, there were watermarks at 1.2m though no damage to this building was recorded.

**Figure 33: No damage was evident at this reinforced concrete frame church at Lepuia'i. As observed in many of the surveyed villages, churches, possibly better built fared much better than other structures.**

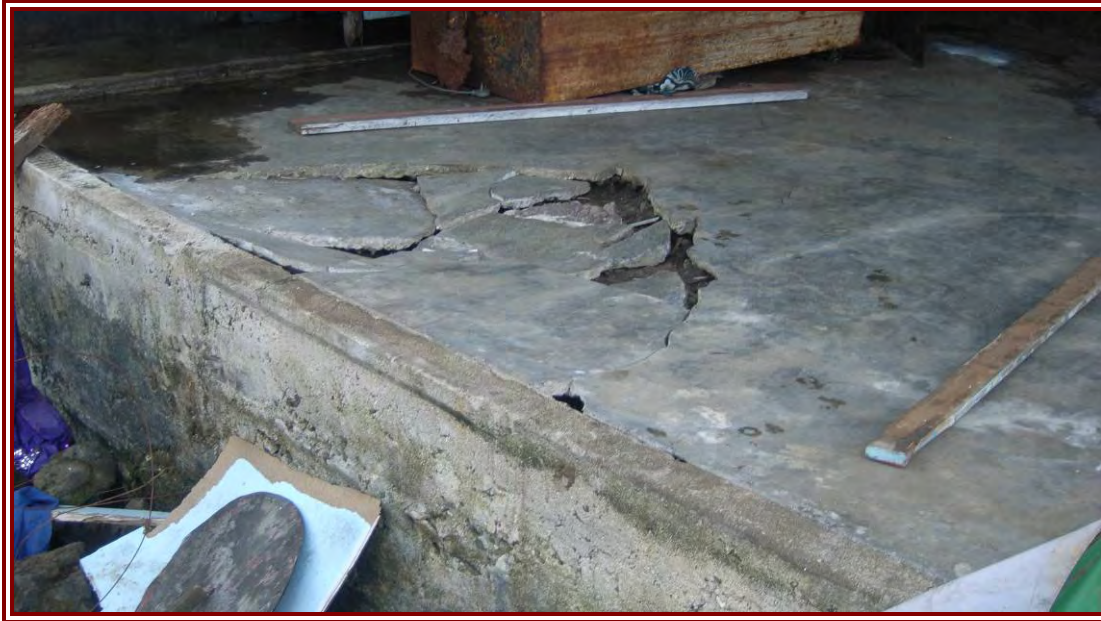
**Figure 35: Evidence of lifting of concrete floors as water rose through foundation and ruptured concrete blinding (usually <20mm thick)**

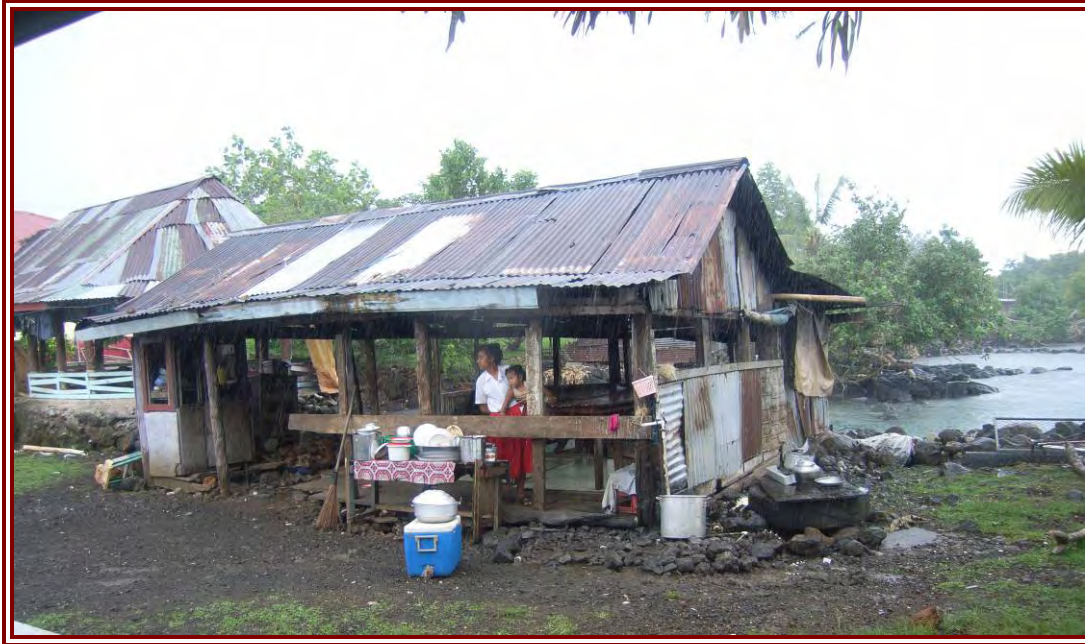
**Figure 36: The cooking houses shown here were mostly destroyed by the incoming waves**

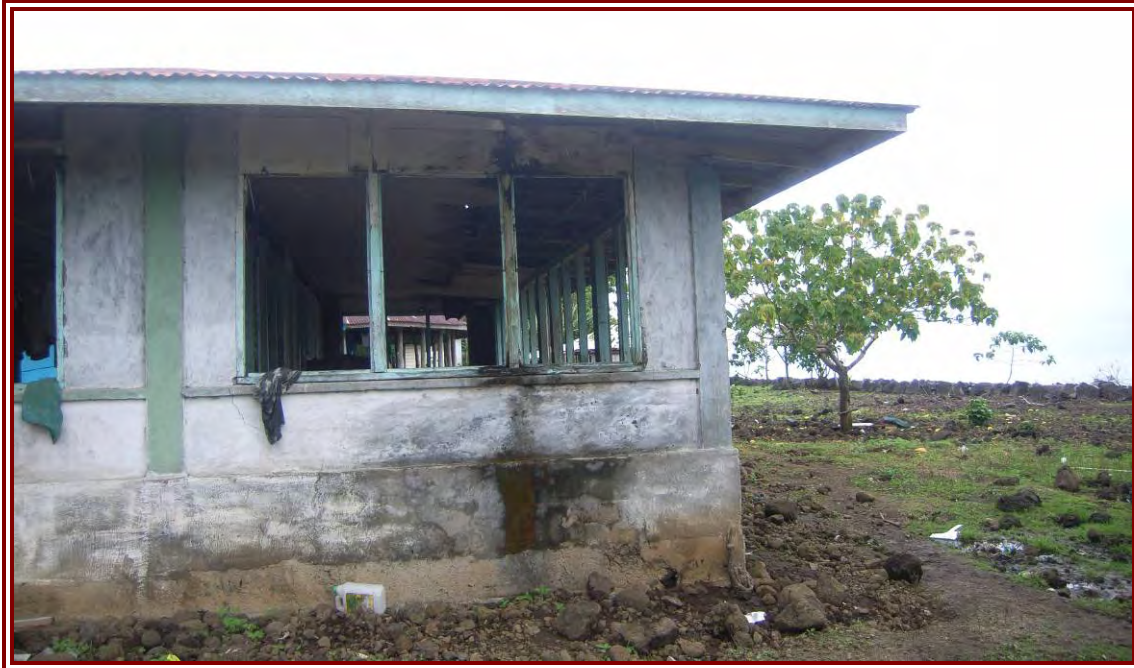
**Figure 37: The incoming water had lifted the floor of the concrete foundation to this residential building, although the foundation was 80cm high**

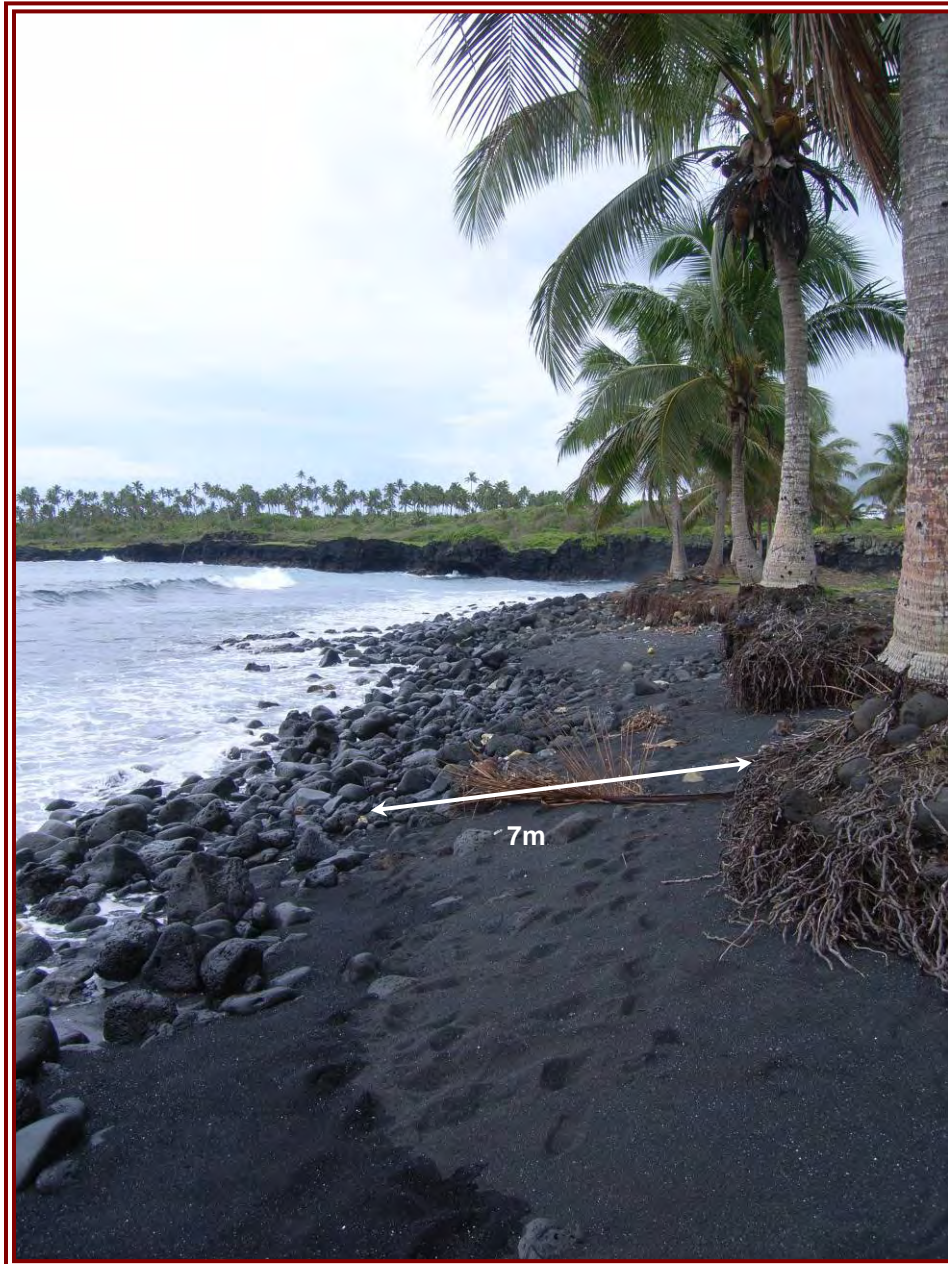
**Figure 38: At Taga, the erosion due to the tsunami is said to be approximately 7m**
