**THE SOUTH PACIFIC ISLANDS EARTHQUAKE AND TSUNAMI  
OF 29<sup>TH</sup> SEPTEMBER 2009**

**A PRELIMINARY FIELD REPORT BY EEFIT**

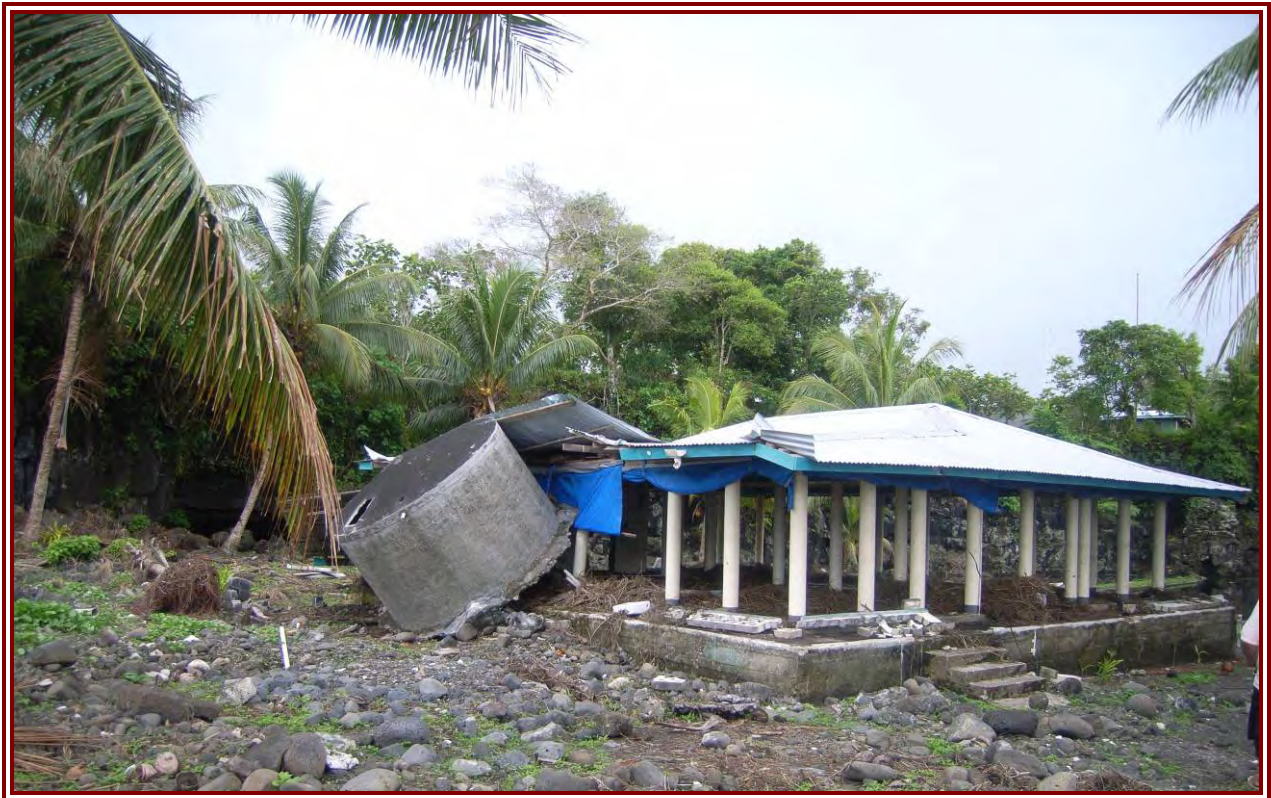
**Figure 39: A photograph showing the impact of a displaced concrete water tank on an open reinforced concrete column building at Taga**

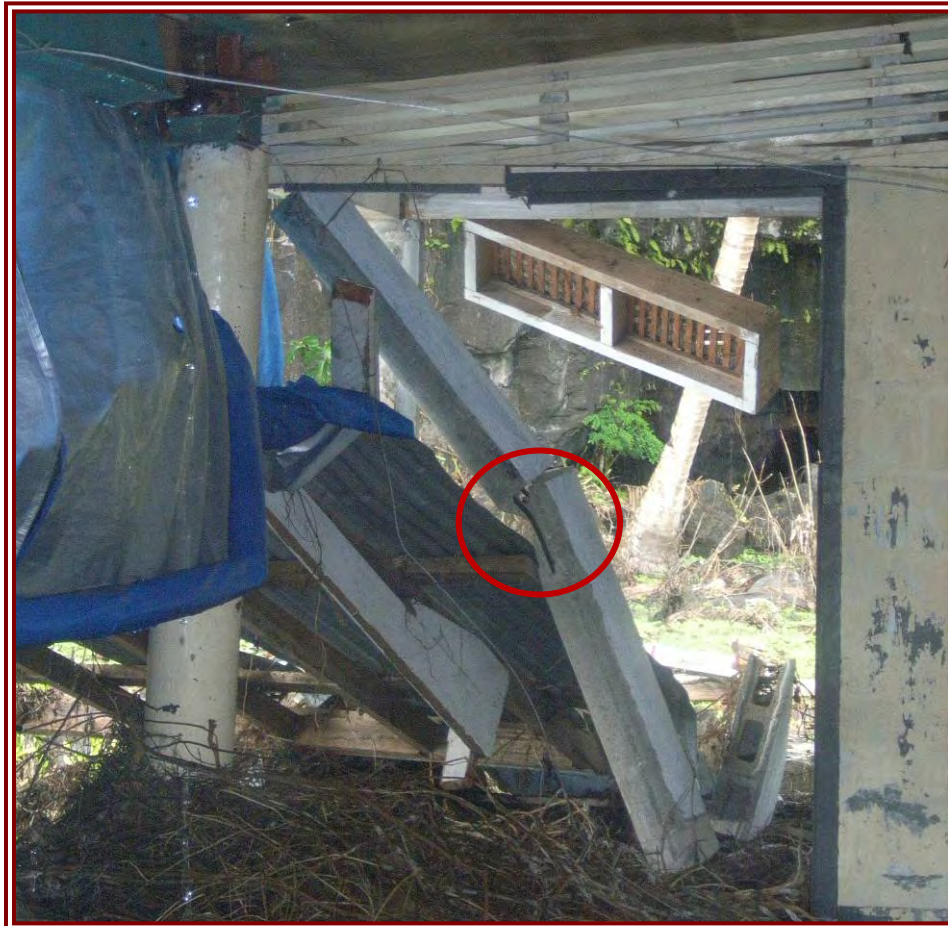
**Figure 40: Two lengths of vertical rebar were exposed in a broken column showing its poor spacing and insufficient lateral reinforcement**

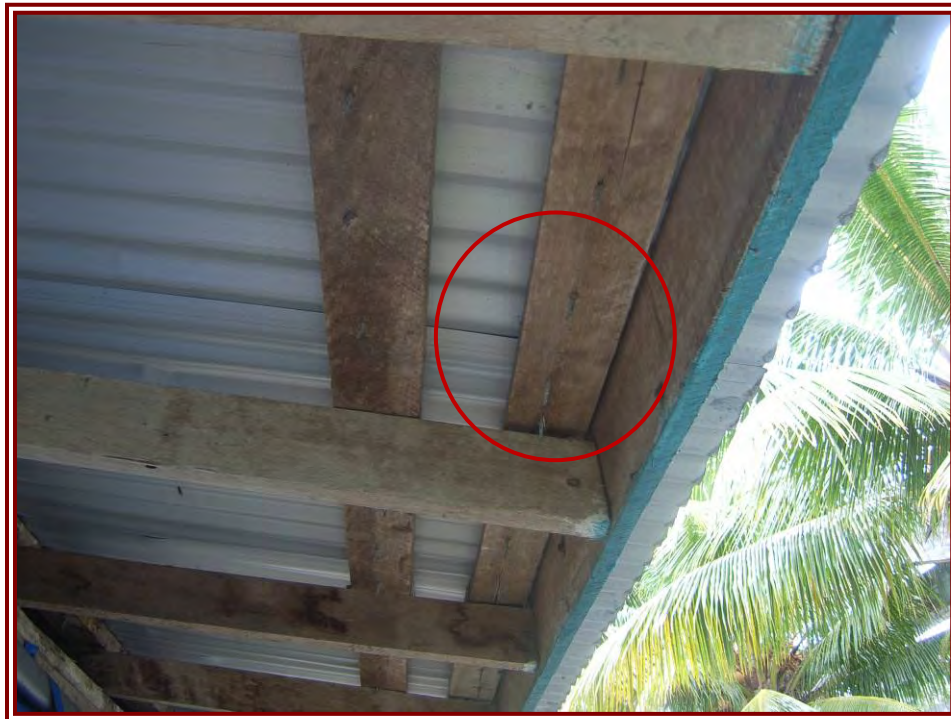
**Figure 41: Nails protruding through a corrugated iron roof to underlying timber beams**
