Chollei Hamlet Watershed Solid Waste Site, Ngarchelong, Palau: Ecological baseline assessment and suggested priority actions

By The Environment, Inc.

IWP-Pacific Technical Report (International Waters Project) no. 27

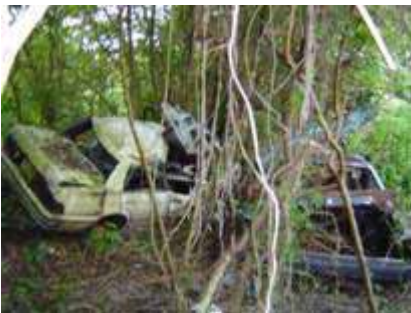
The project directly impacted forests surrounding the site to the northwest, west and south and east of the waste site. We observed much debris and garbage outside the site within the nearby forest including discarded cars. The forest acts as a natural sediment trap and filtering system for this watershed. The flow of sediment and leachate is retarded by the roots and stems and fallen leaves and low-lying grasses and plants that cover the ground. The forest provides habitat and food for wildlife and the trees are a source of lumber for building. We heard many birds and saw a native palm (*demailei*) that had been recently cut into strips for construction. Removal of forest will cause the loss of animals that depend upon the forest for food and shelter. Wherever possible, large sections of especially undisturbed forests should be left intact. These forests serve as important buffer areas for the nearby river and watershed. Although this site does not directly impact the nearby mangroves, indirect impacts can result from uncontrolled leachant and debris flowing into the mangroves from the waste site. We recommend the establishment of at least a 20 m (60 foot) vegetation buffer zone around the waste site and a barrier fence within the footprint of the existing waste site. The large trees along the periphery of the existing waste should be outside the barrier fence and waste site.

Discarded vehicles SW along road.

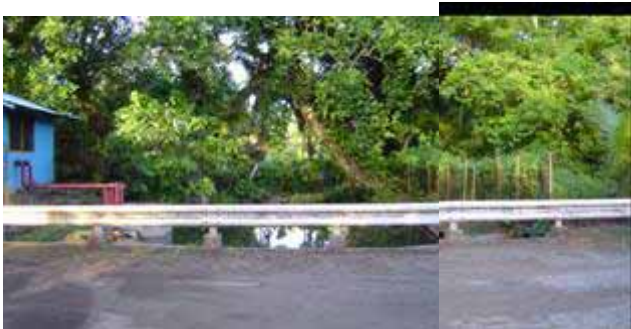
Stream to NE of site, water pump station to left.

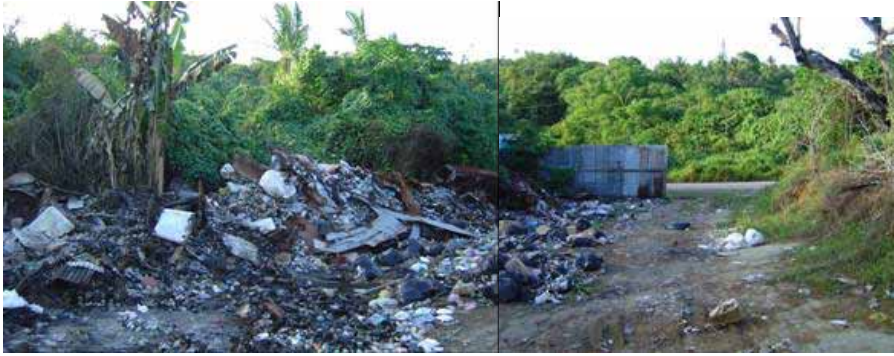
Fire has been an ongoing problem at the waste disposal site. Evidence of a recent fire were visible at the site (Plate 3). Fire is a health hazard due to the chemicals released in the smoke by the fire, which can spread to within the vicinity of residential homes on windy days.

Northwestern and North view of disposal area in Chollei, Dec 6, 2004

<p>Fires have occurred on site within recent weeks. Uncontrolled fire causes air pollution and potential health risks to nearby residents, hotel guests and workers in the vicinity.</p>	<p>A fire control and prevention plan, with an inventory of all necessary fire control equipment, should be developed for the site.</p> <p>Rain catchment tanks should be designed and constructed with capacities sufficient to hold water for periods of fire outbreaks, dust control and droughts.</p> <p>Construct fire barriers around the periphery of the site to avoid fire outbreaks to adjacent areas.</p> <p>Place a sign on site that bans smoking while on site, or setting fires on site without an EQPB and State permit.</p>

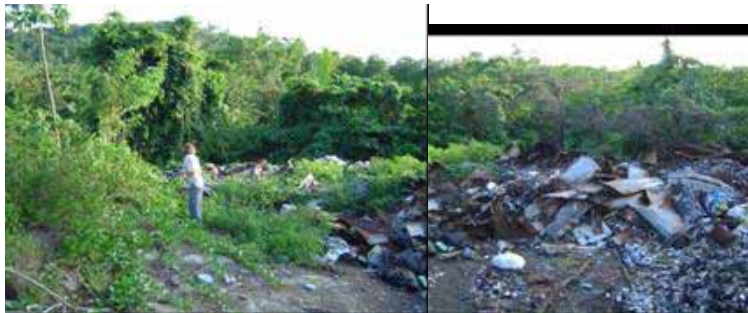
Southwest and southern end of disposal area in Chollei, Dec 6, 2004

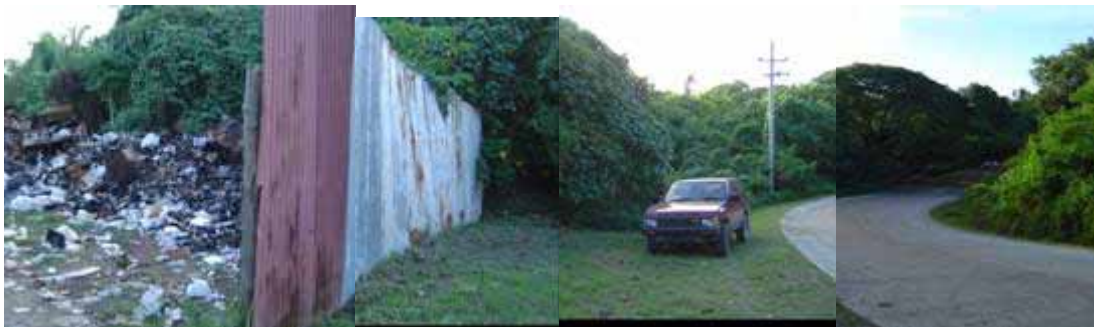
NW and West view of site inside and outside disposal area

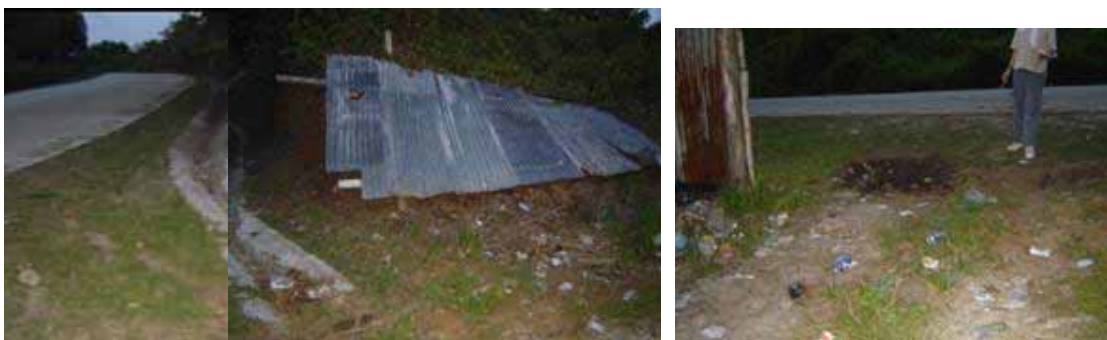
NE view showing fallen corrugated fence and swale for road.

Entrance to the disposal area.

The use of heavy equipment and the traffic flow for waste disposal can cause disturbance within the nearby community and impact the normal behavior of wildlife and birds. A perimeter corrugated barrier fence landscaped with native bushes and trees would serve as a buffer for noise and also prevent movement of wildlife into the site, or potentially harmful invasive organisms from entering the surrounding area.

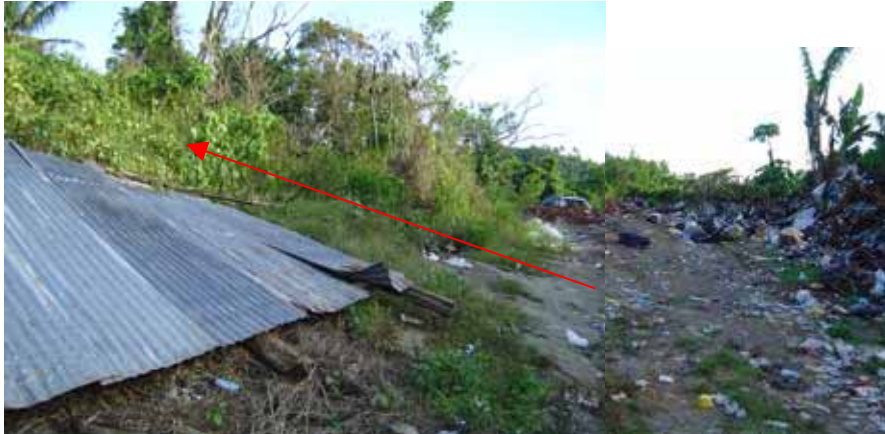
E and NE view of disposal area with fallen fence. Red arrow shows the direction transect line was set.

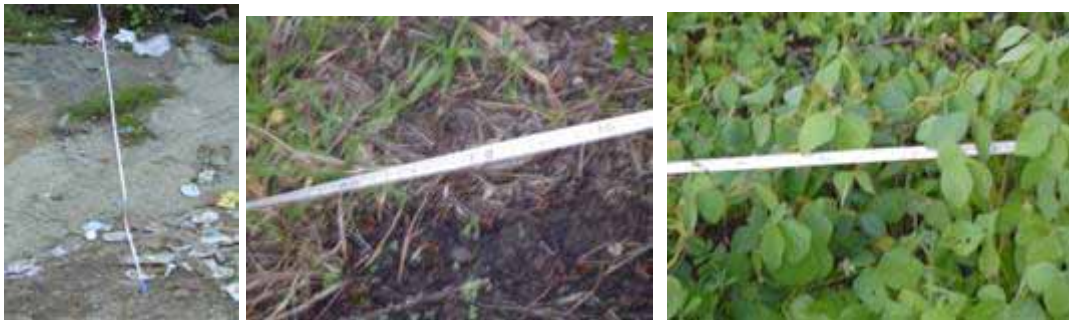
Ground cover plants included grasses and sedges, small plants, and vines. We quantified ground cover every 10 m along the transect line. This data was used to help delineate vegetation types for mapping. The legume, *Desmodium* sp., the grass, *Ischaemum* sp., a *Sida* sp. plant, and one unidentified grass were found as ground cover in the less disturbed northern and northeastern section of the site (see Table 3 and Plates 4-5).

Ground cover at 0 m no vegetation, 10 m with burnt grass and 20 m with *Desmodium*.

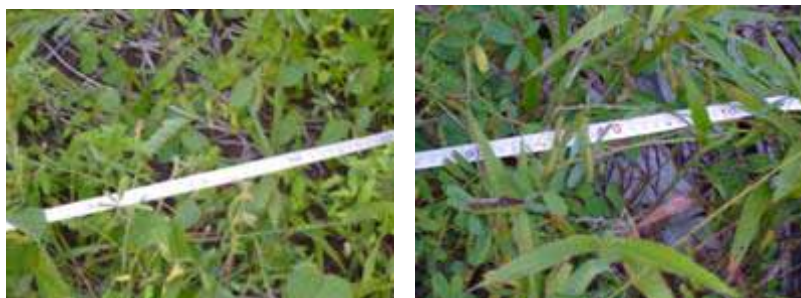
Ground cover at 30 and 40m along transect at northeast end of landfill.

Includes *Ischaemum*, *Desmodium*, and *Sida* spp.

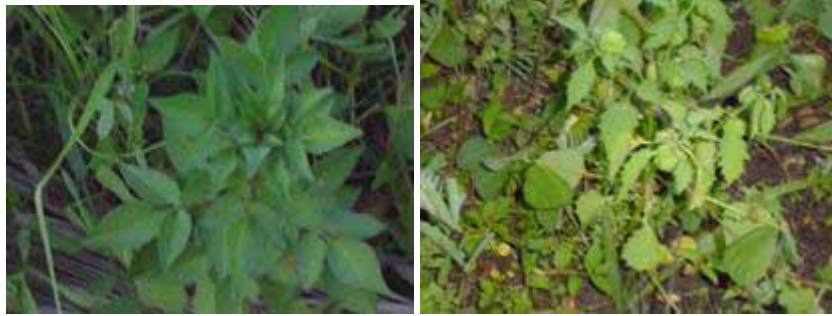
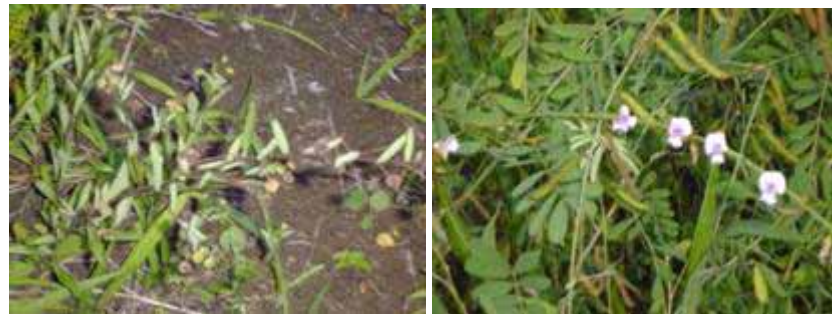
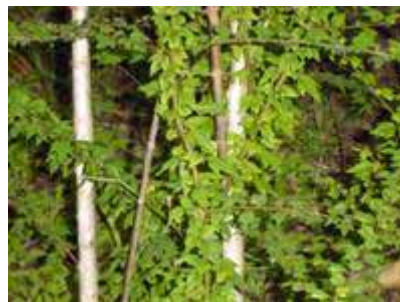
The invasive indigenous vine, *Merremia peltata* (kebeas) was present. This is a noxious weed that is hard to kill and has spread throughout Palau. This vine is especially common once an area is cleared. The most effective way to remove this vine is to dig out its roots and burn it. Cutting the vines is ineffective, in fact may create a greater problem.

Weeds found within landfill along NE section of landfill boundary

The indigenous vine, *Merremia peltata*, or *kebeas*, was found on site. This vine is out of control along the entire Compact road and a control or eradication program for this vine should begin immediately. Any other noxious weeds that are found on site now or during the proposed cover fill needs to be eradicated if possible and if not at least contained.

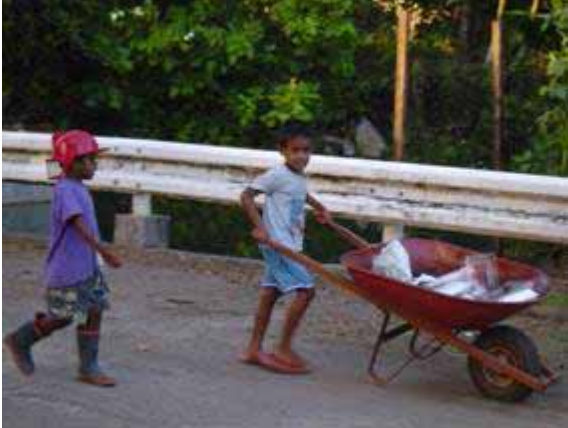
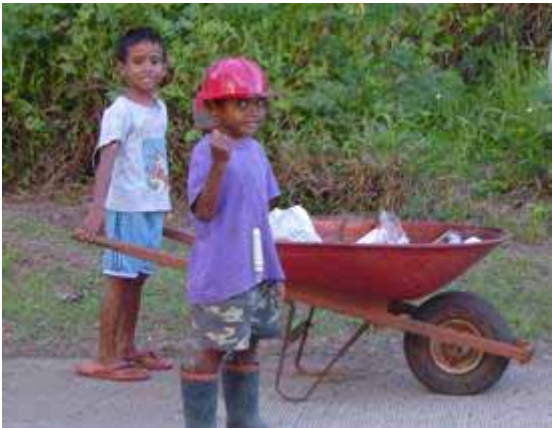
During our assessment, two young boys were heading to the dump with waste in a wheelbarrow (Plate 6). One was wearing boots but the other only zoris. The boys entered the site, unsupervised, to dump their waste. There were sharp bottles, metal, and debris on the ground and mosquitoes, flies, and foul odors. It is important to educate the families about the health risks associated with disposal sites from dengue, tetanus, and basic dangers associated with unmanaged wastes. Children should not be allowed entry beyond a

Young boys going to the Chollei disposal area, Dec 6, 2004.

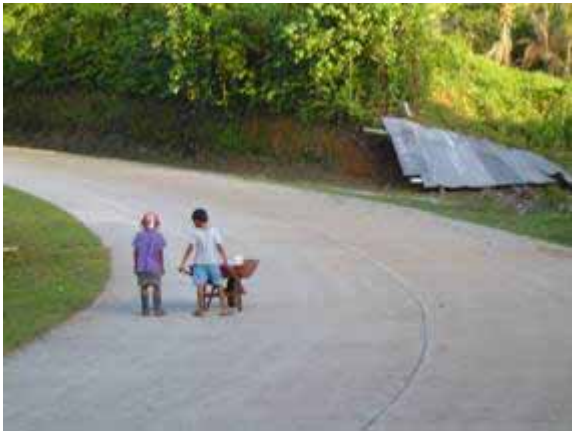
Young boys heading to the Chollei disposal area, Dec 6, 2004.
