**THE SOUTH PACIFIC ISLANDS EARTHQUAKE AND TSUNAMI  
OF 29<sup>TH</sup> SEPTEMBER 2009**

**A PRELIMINARY FIELD REPORT BY EEFIT**

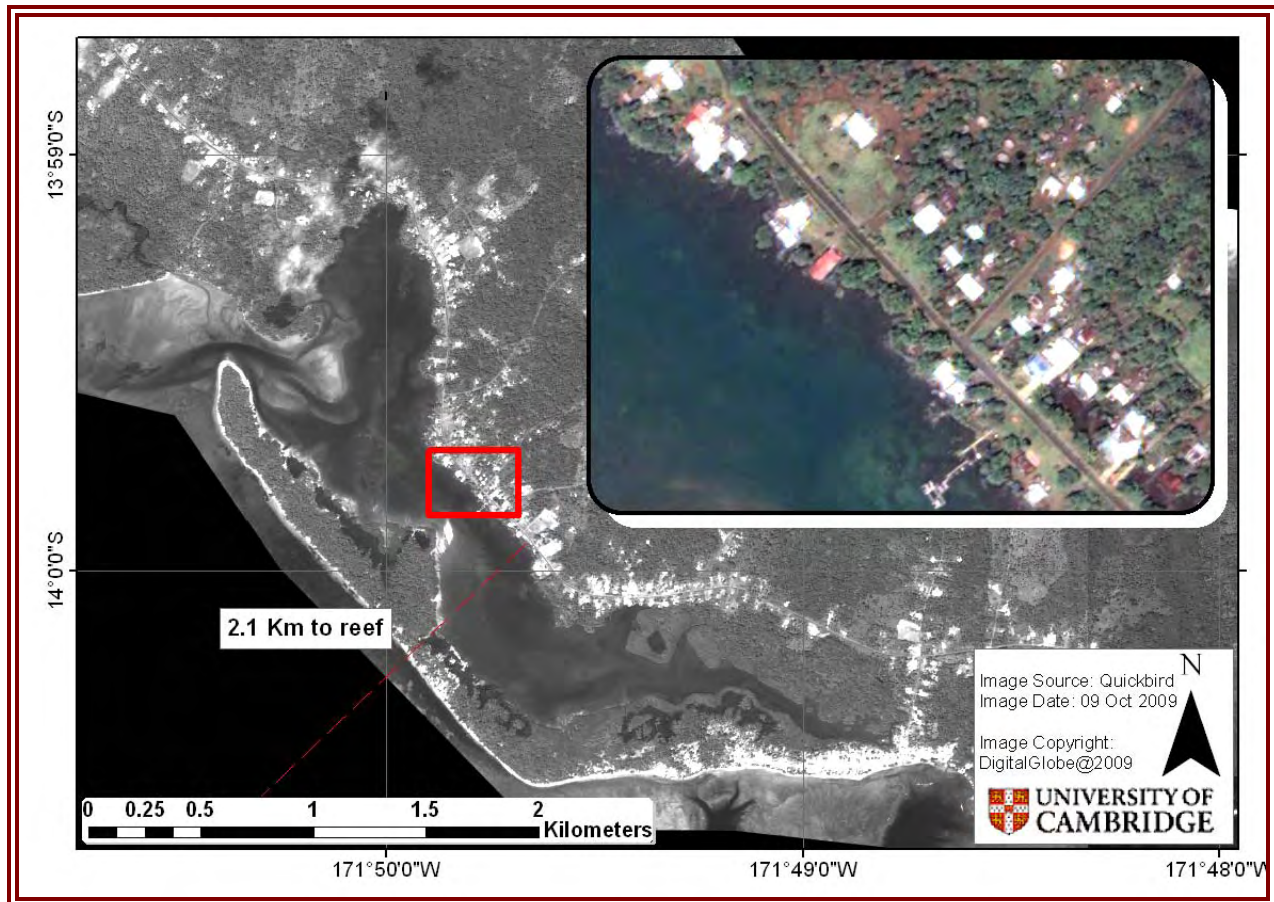
This village suffered no damage to buildings as it is in a sheltered lagoon, as shown in Figure 6. A resident interviewed by the team had heard the warning on the radio that morning and left his house but later returned and observed there had been no change in sea level. He also mentioned that fishermen had observed erosion on the seaward side of the sandbank offshore after the tsunami.

**Figure 6: The village of Fusi is protected by a spit as shown in this satellite imagery. The inset post event image shows no signs of damage, as confirmed in the field.**

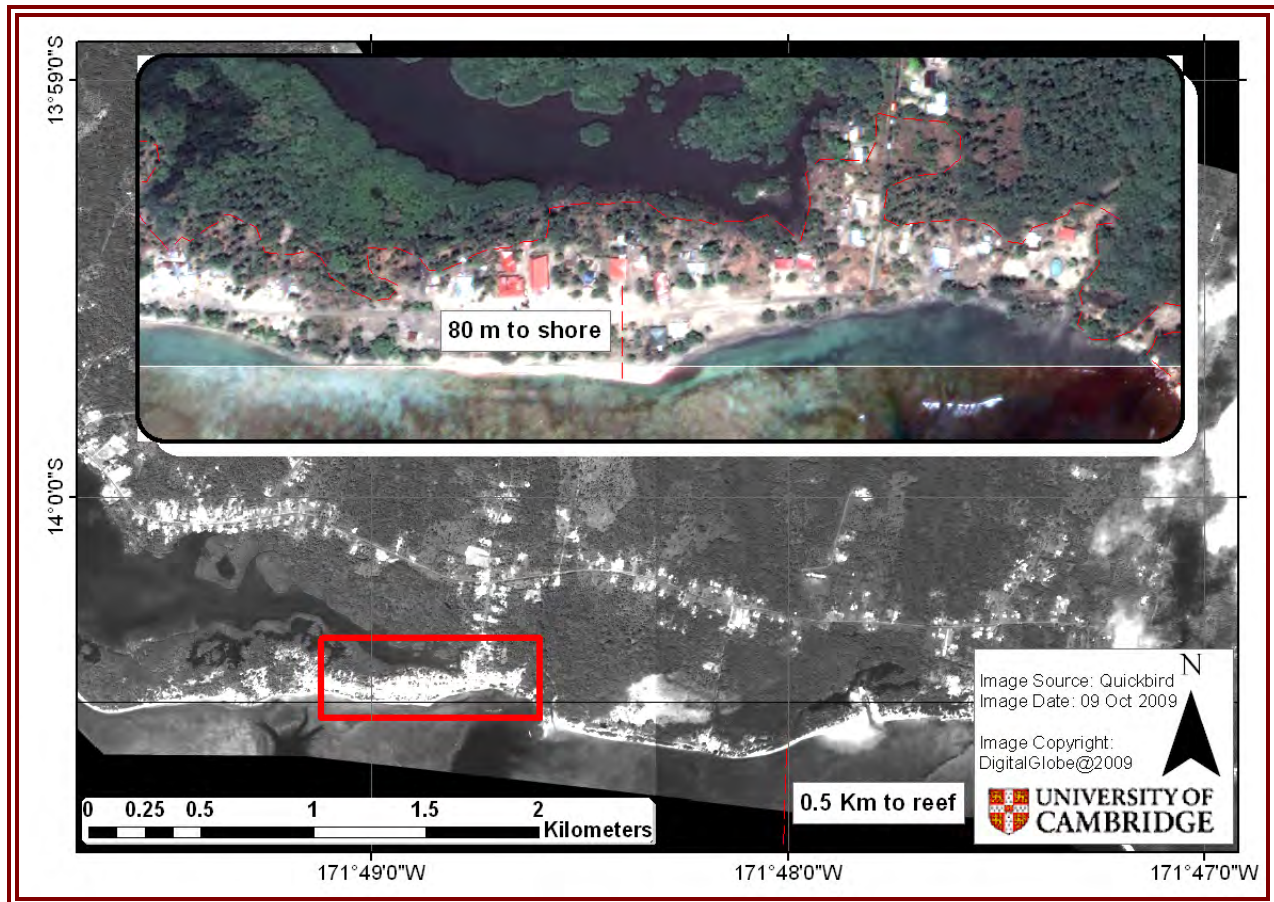
**Figure 7: Tafitoala have no exit routes inland at the west end of the village as shown**

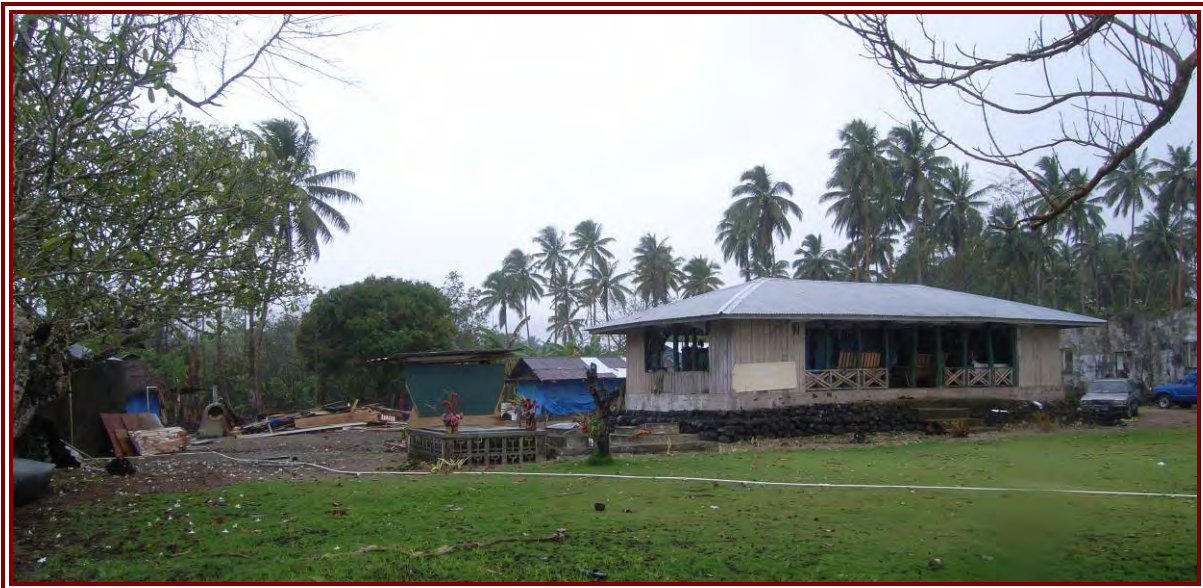
**Figure 10: A reason for not relocating with the rest of the village was determined by the location of ancestral graves**

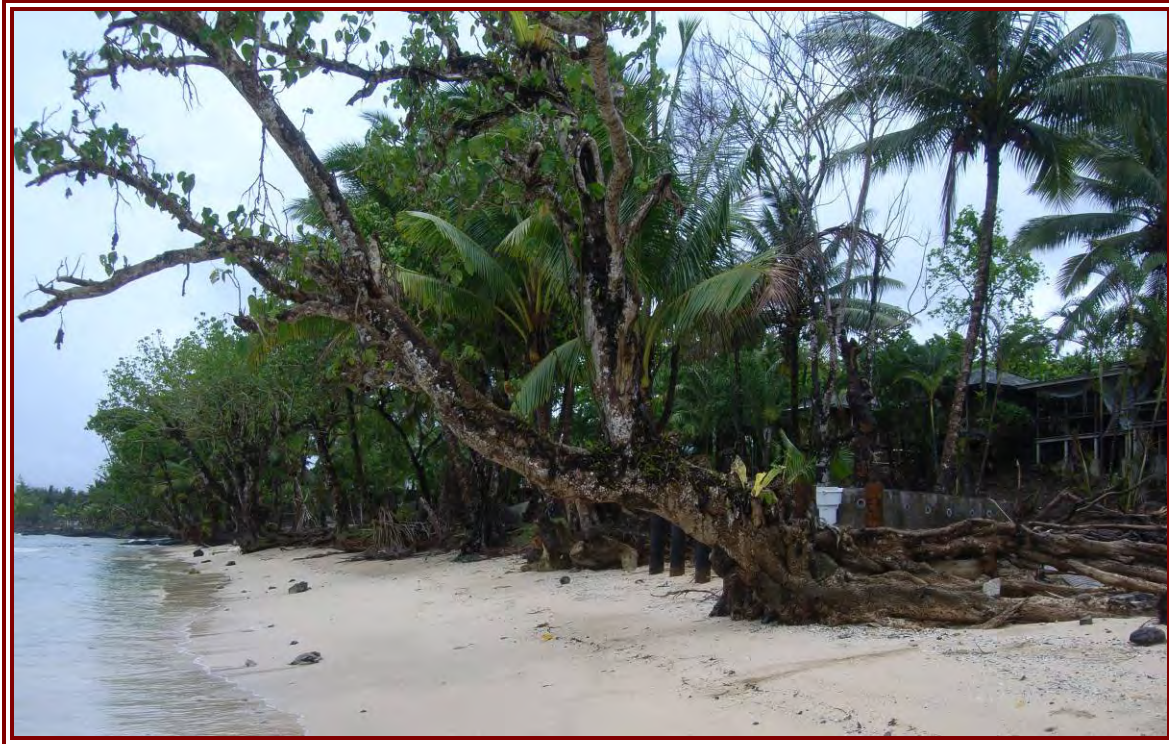
The Sinalei Reef Resort just east of Maninoa suffered substantial damage to all its coastal assets. Along this resort, there is virtually no man-made coastal protection, only natural shoreline (shown in Figure 12).

**Figure 12: The natural shoreline as witnessed at the Sinalei Reef Resort**

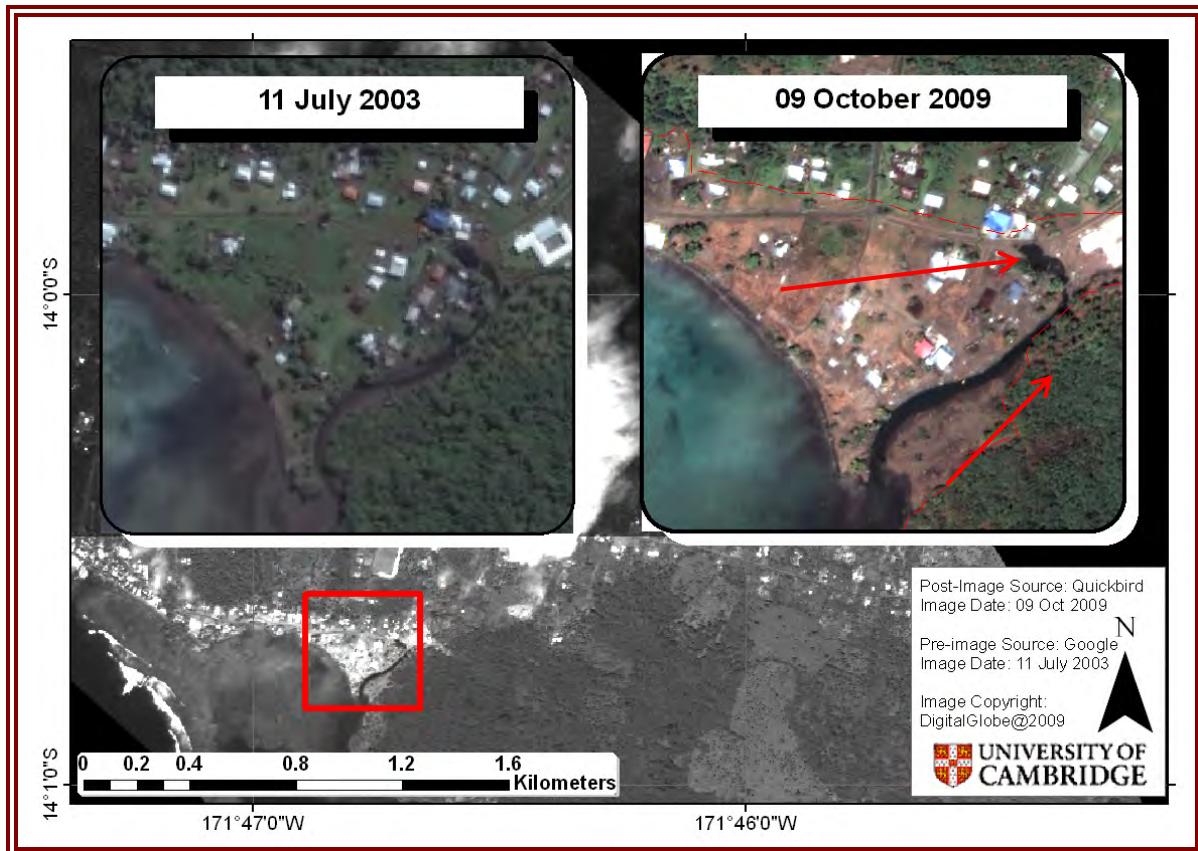
The coastline of this village is a rocky beach with dark sandy fluvial deposits. Some of rocks had been moved from the beach by the waves and deposited inland. There is a river to the east of the village which created a conduit for the tsunami to propagate inland a distance of 300m. The tsunami was said to have followed two paths through the village, one along the river and the other through the houses over an elevated ridge as indicated in Figure 15. The water inundation to the west of Si'umu-sisifo was measured at 77m.

**Figure 15: The tsunami was said to have followed two paths through Si'umu-sisifo, one along the river and the other through the houses over an elevated ridge shown in this imagery**

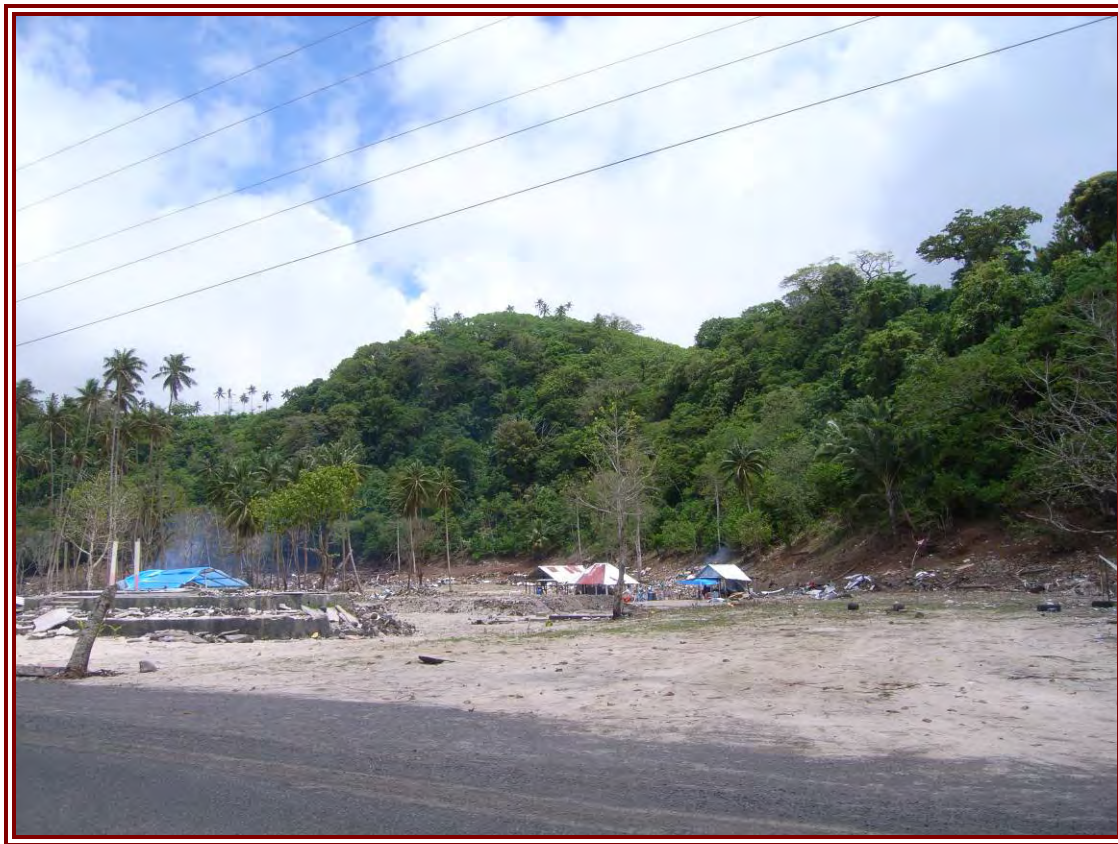
**Lalomanu** - This village, a famous tourist destination with many beach fales and tourist facilities were completely destroyed by the tsunami. During the team's visit, significant clean-up operations were underway following the devastation in the area. As shown in Figure 24, only concrete base foundations remained. This village was entirely exposed to the incoming waves, which can explain the high level of destruction, and the steep vegetated cliffs immediately inland of the beach resorts prevented effective evacuation.

**Figure 24: View of the village of Lalomanu from the southern coastal road**
