MARINE POLLUTION RISK ASSESSMENT FOR THE PACIFIC ISLANDS REGION

(PACPOL PROJECT RA1)

VOLUME 1: MAIN REPORT

**Pacific Ocean Pollution Prevention Programme (PACPOL),
South Pacific Regional Environment Programme (SPREP)**

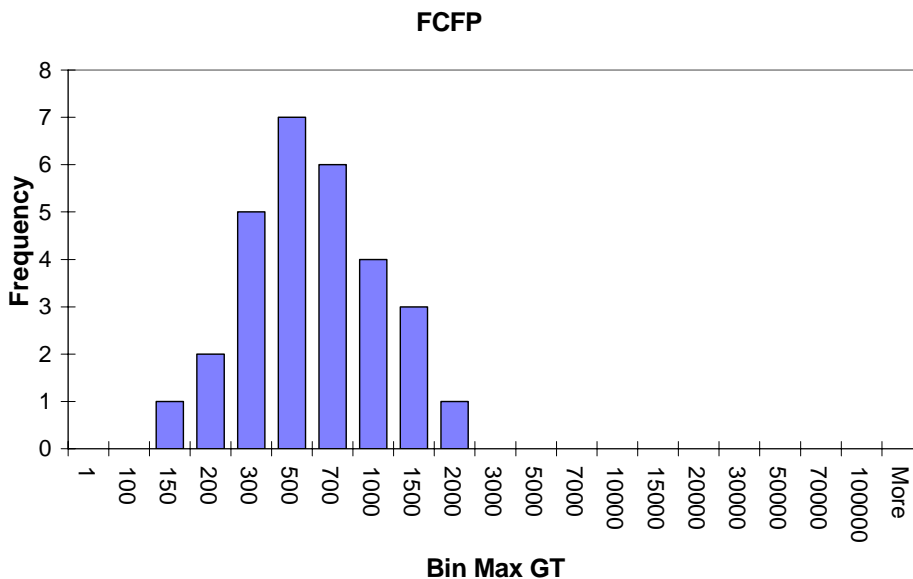
Figure 1.9. Size distribution of interisland passenger/cargo ferries.

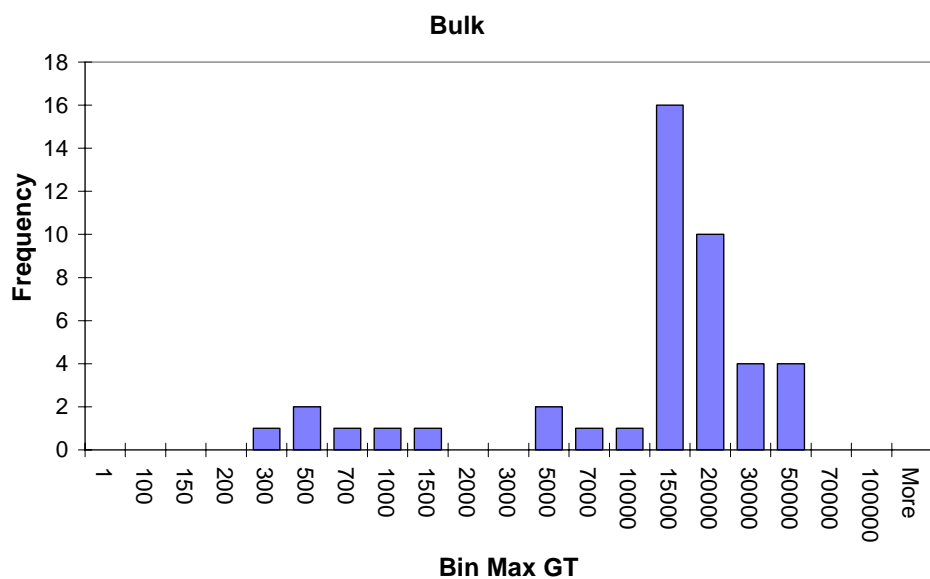
Figure 1.10. Size distribution, bulk freighters

There are a few established bulk commodity routes in the region. Phosphates from Nauru is a declining trade. Squash from Tonga to Japan is seasonal, and accounts for about five voyages per year. Sugar from Fiji goes mostly to European countries. Through the Indian Ocean and Suez. Copper ore concentrate from Papua New Guinea goes to smelters in Australia, Japan and Asia.. New Caledonia has 20% of the world's known nickel, but this does not generate a large bulk trade because all of the ore is smelted in-country. Figure 4.10 shows the size distribution of bulk vessels

in our database. The bulkers in the coastal PNG trade and log exports are generally smaller than 5,000 GT. Bulkers in the other Pacific trades are mostly in the 10,000 to 20,000 GT range.

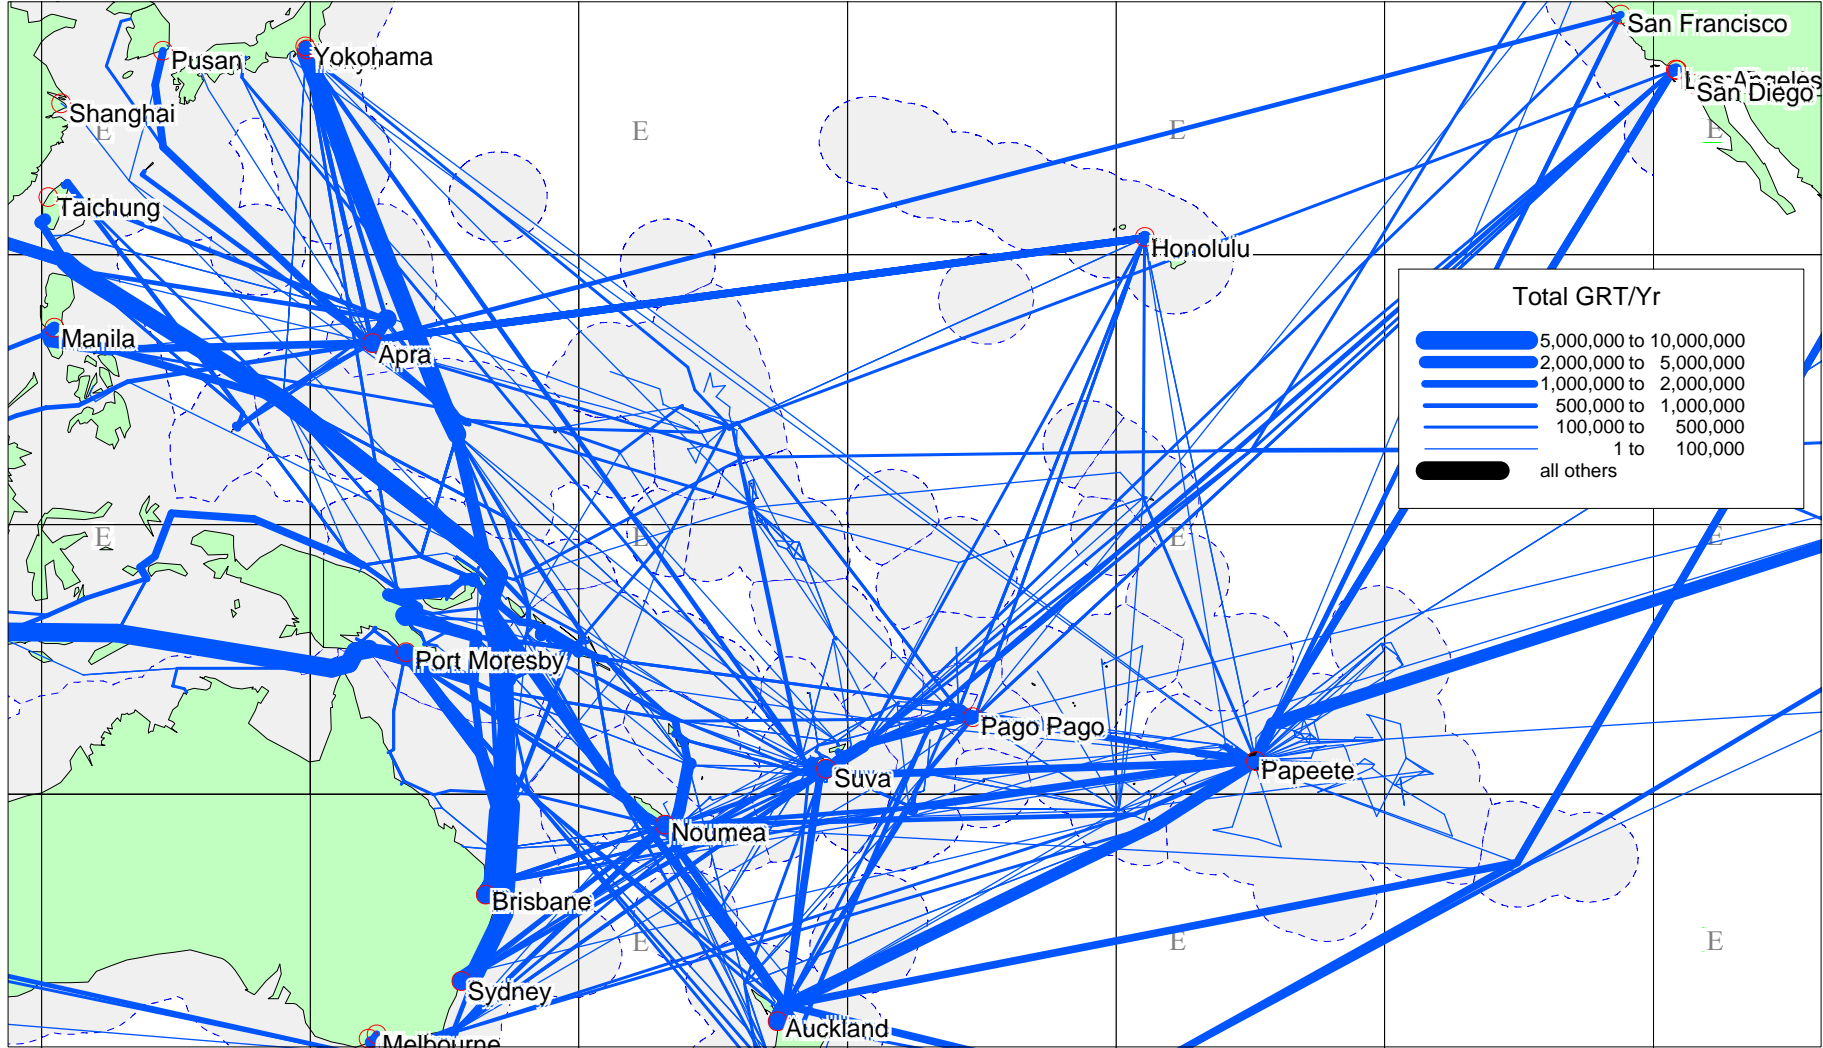
Figure 1.12. Total vessel traffic by GT.

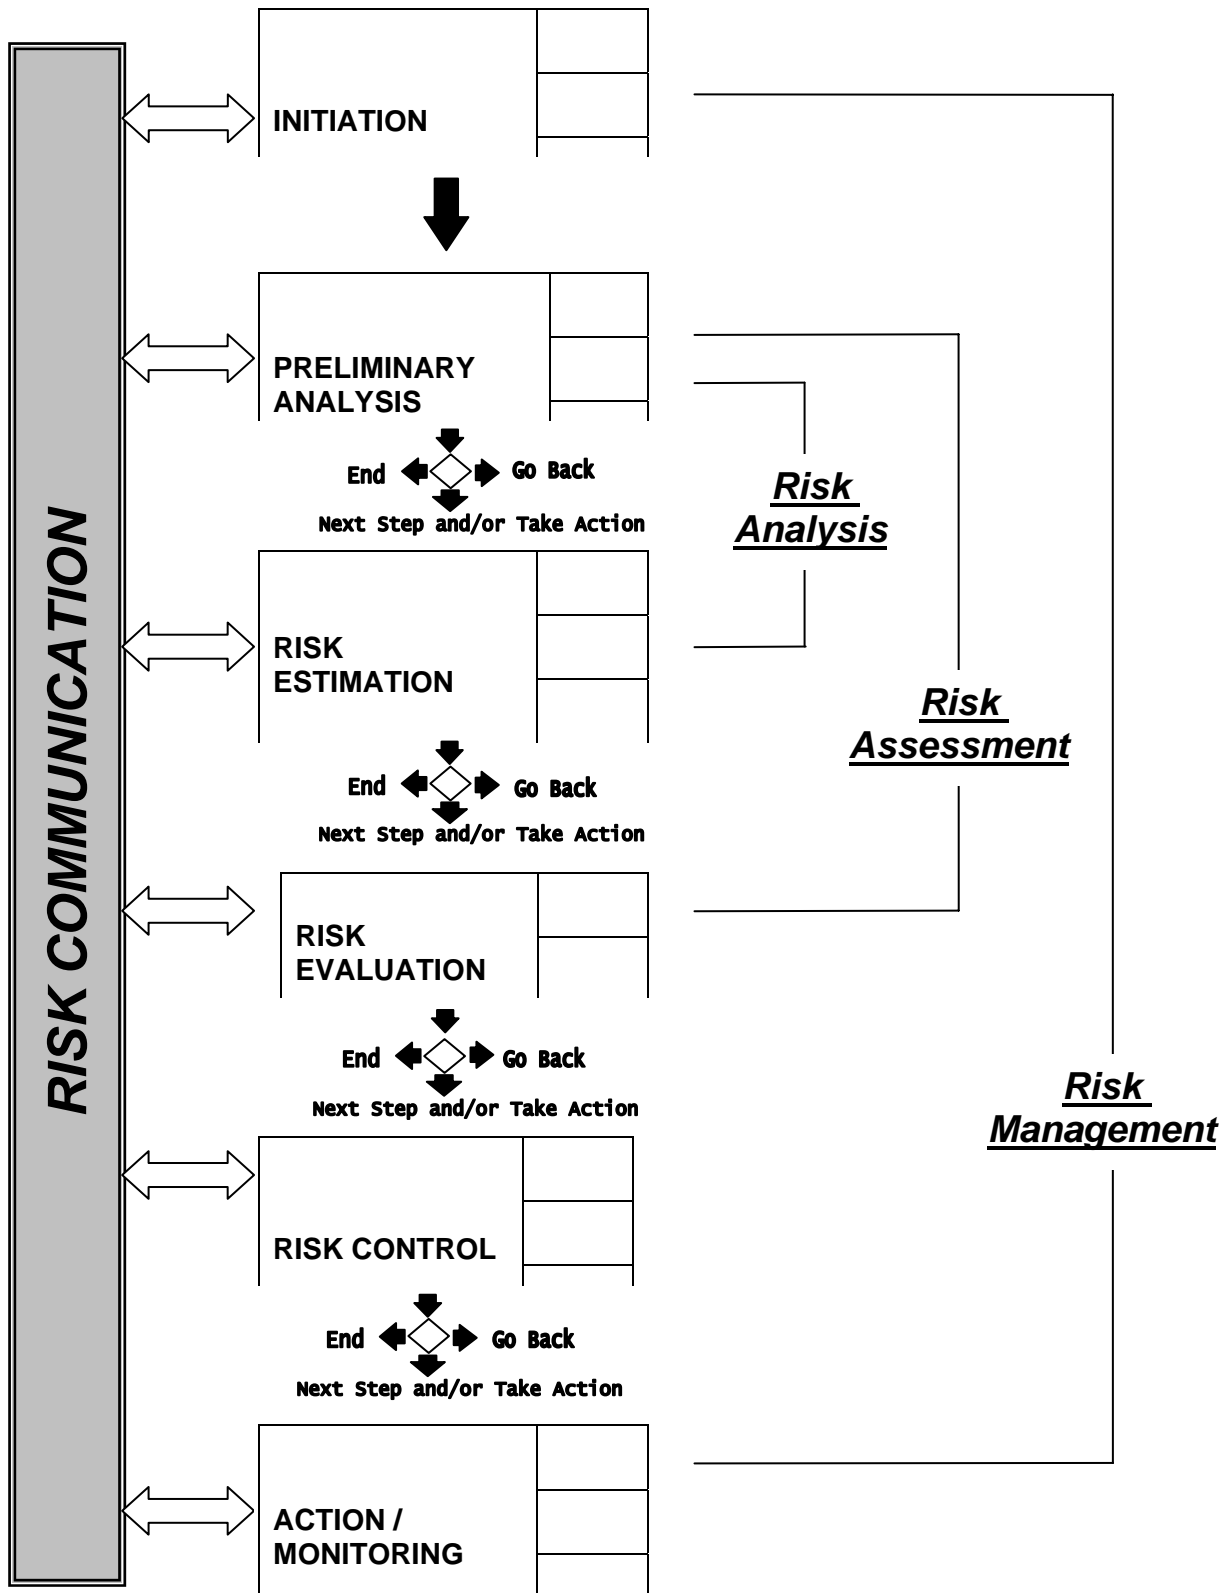
Figure 1.1. Steps in a risk management decision-making process and hierarchy of risk management concepts.

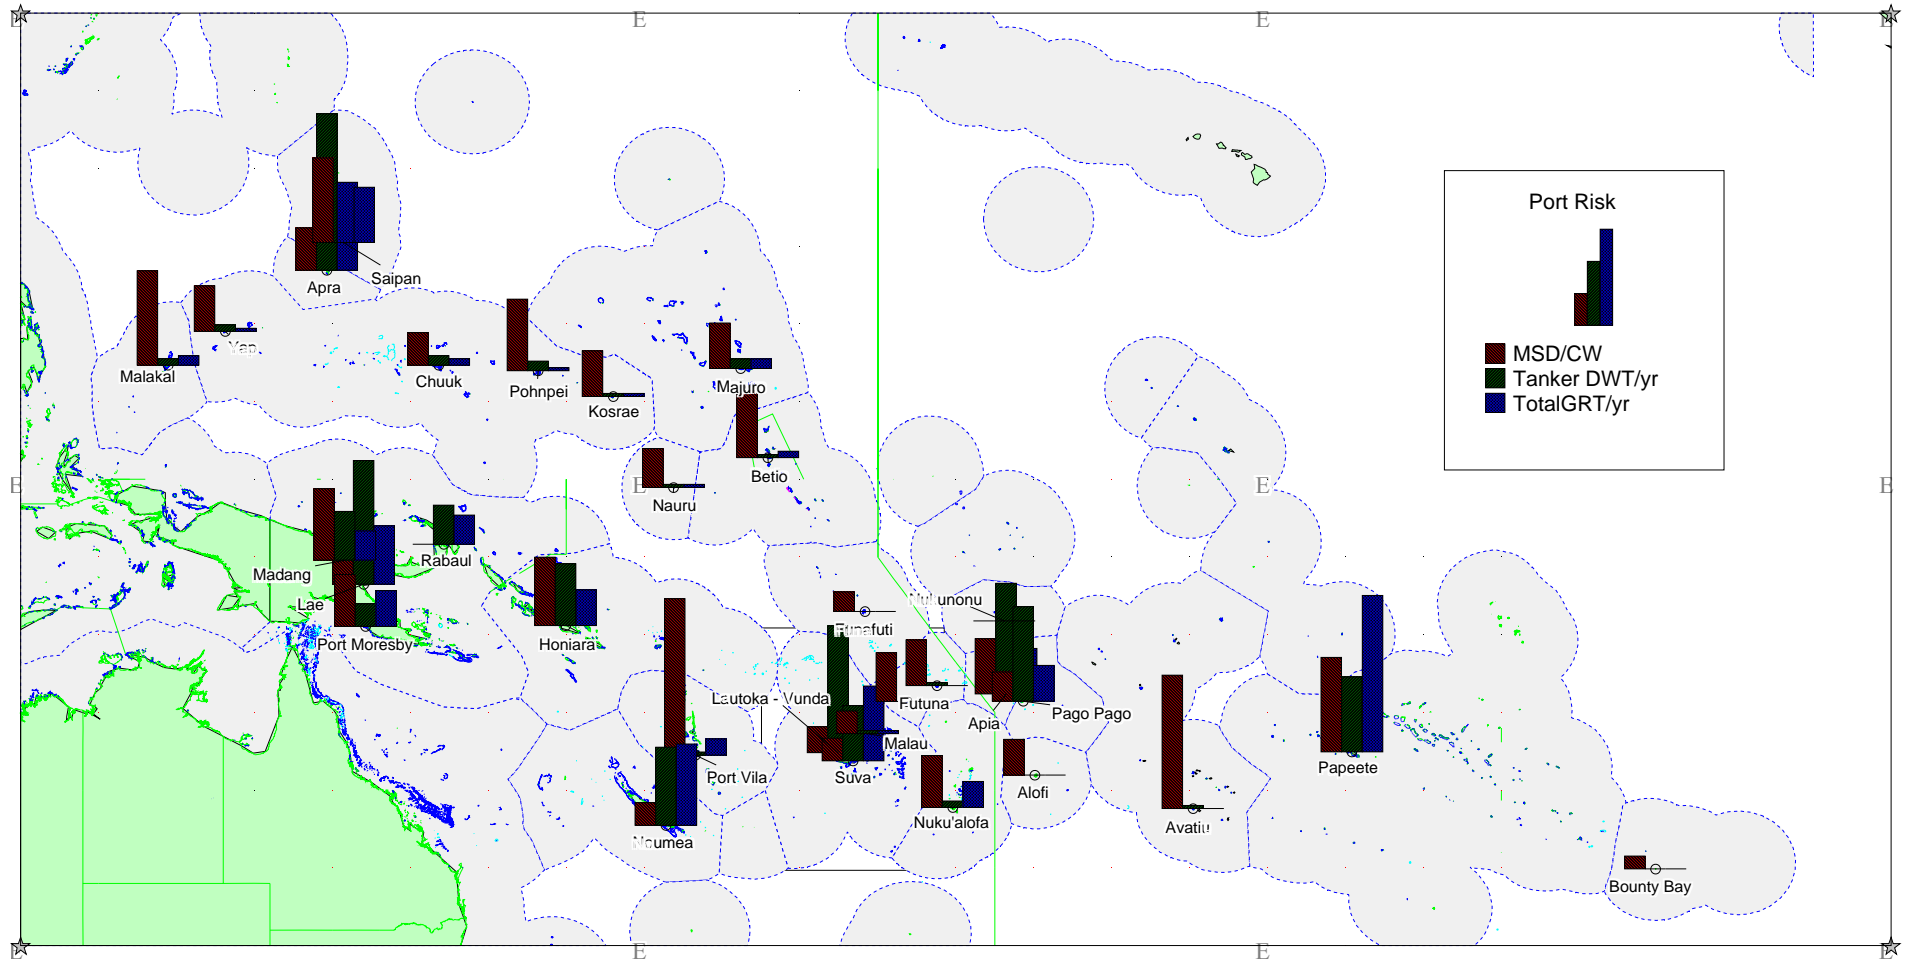
Figure 1.18. Regional distribution of port risk

Only Port Vila, Republic of Vanuatu, and Avatiu, Rarotonga, Cook Islands showed a Channel Width to Minimum Safe Distance (CW/MSD) ratio of less than one. This means that the existing channel width at these ports is less than that required for the conditions and vessel size. The reference vessel chosen for the calculating MSD at Avatiu was a small coastal freighter of only 100 DWT. In fact, vessels of up to 3000 DWT, including MR tankers and container liners routinely enter Avatiu in favourable conditions.

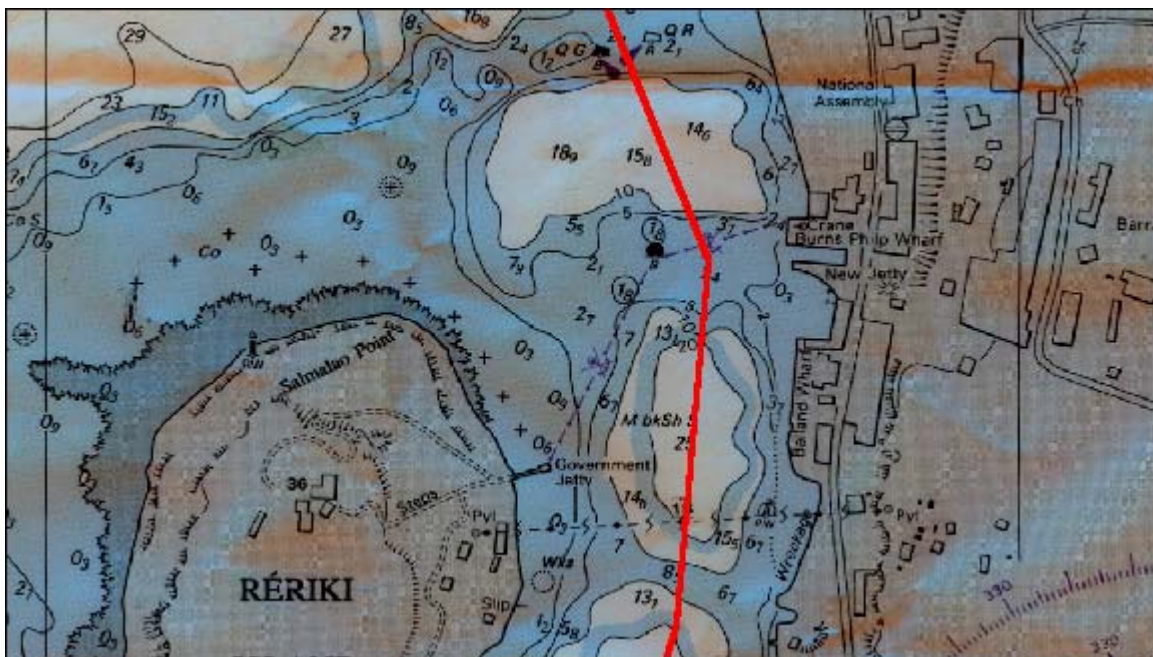
Figure 13. Port Vila Harbour.

High risk waterway: Entrance to Paray Bay to fuel jetty.

COUNTRY	Republic of Vanuatu
PORT	Port Vila, Mele Bay
HIGH RISK WATERWAY	Entrance to Paray Bay to fuel jetty

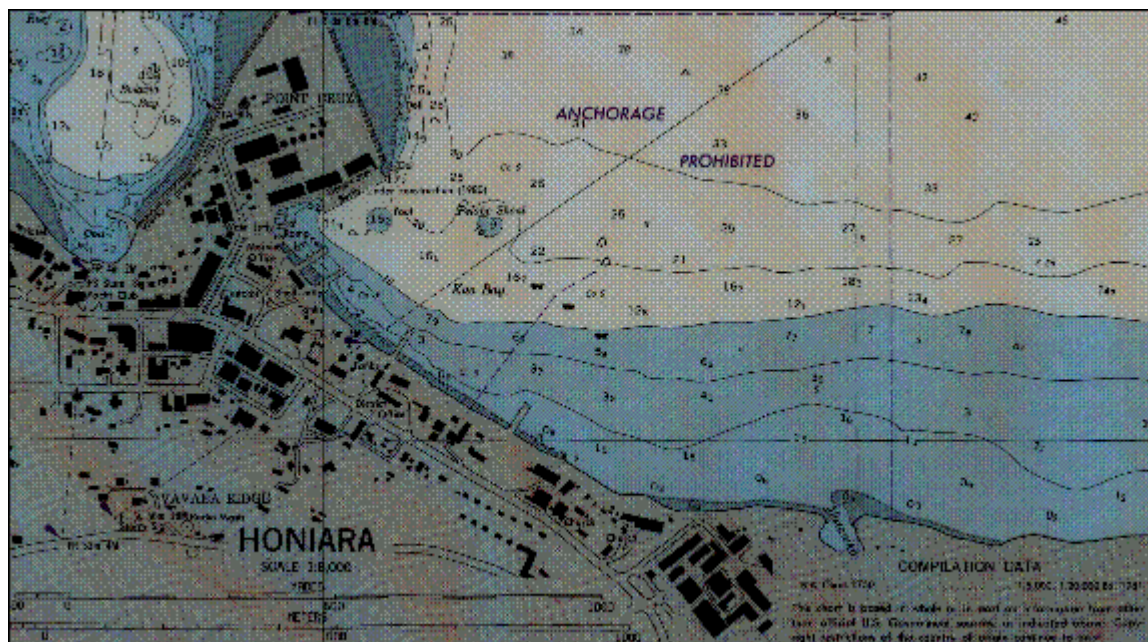
Figure 14. Honiara.

High risk waterway: Approach to tanker moorings.

COUNTRY	Solomon Islands
PORT	Honiara
HIGH RISK WATERWAY	Approach to tanker moorings

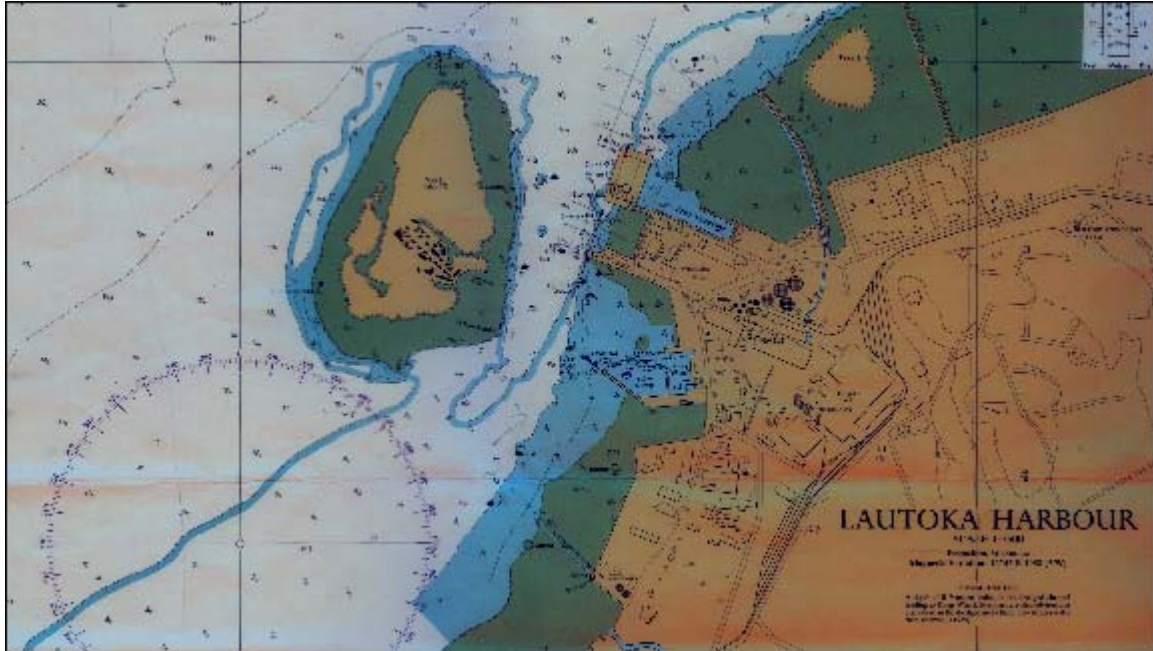
Figure 16. Lautoka Harbour.

COUNTRY	Republic of Fiji
PORT	Lautoka, Vuda Point
HIGH RISK WATERWAY	Navula Passage

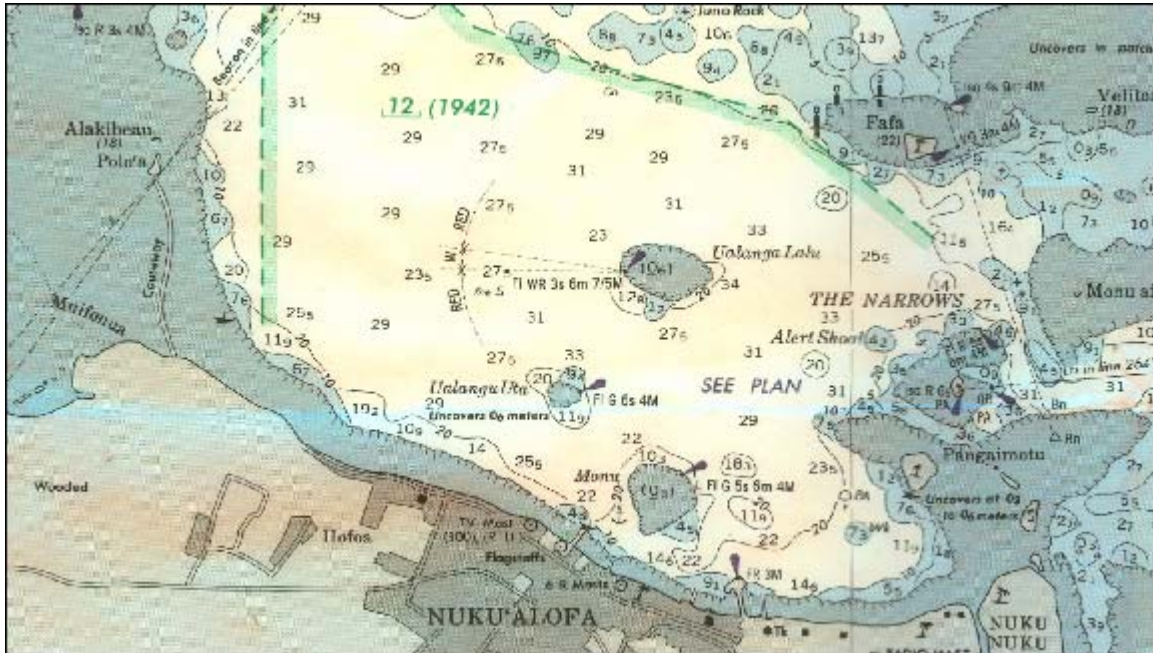
Figure 22. Nuku'alofa Harbour.

COUNTRY	Kingdom of Tonga
PORT	Nuku'alofa
HIGH RISK WATERWAY	Ava Lahi Passage—turn to 215°

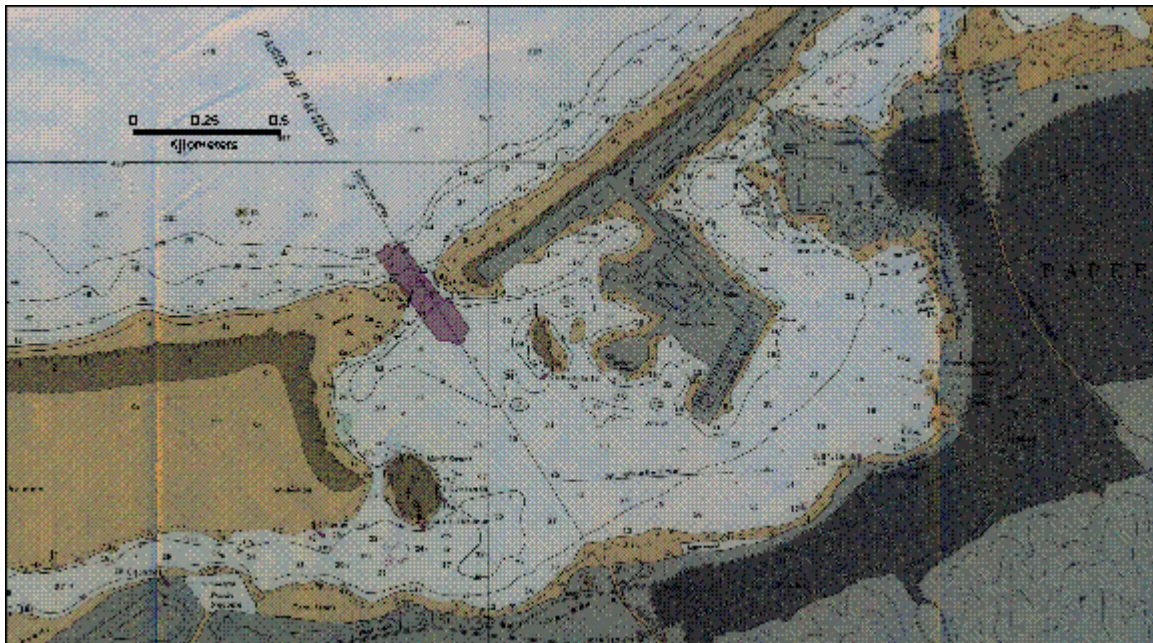
Figure 15. Papeete Harbour.

COUNTRY	French Polynesia
PORT	Papeete
HIGH RISK WATERWAY	Passe de Papeete

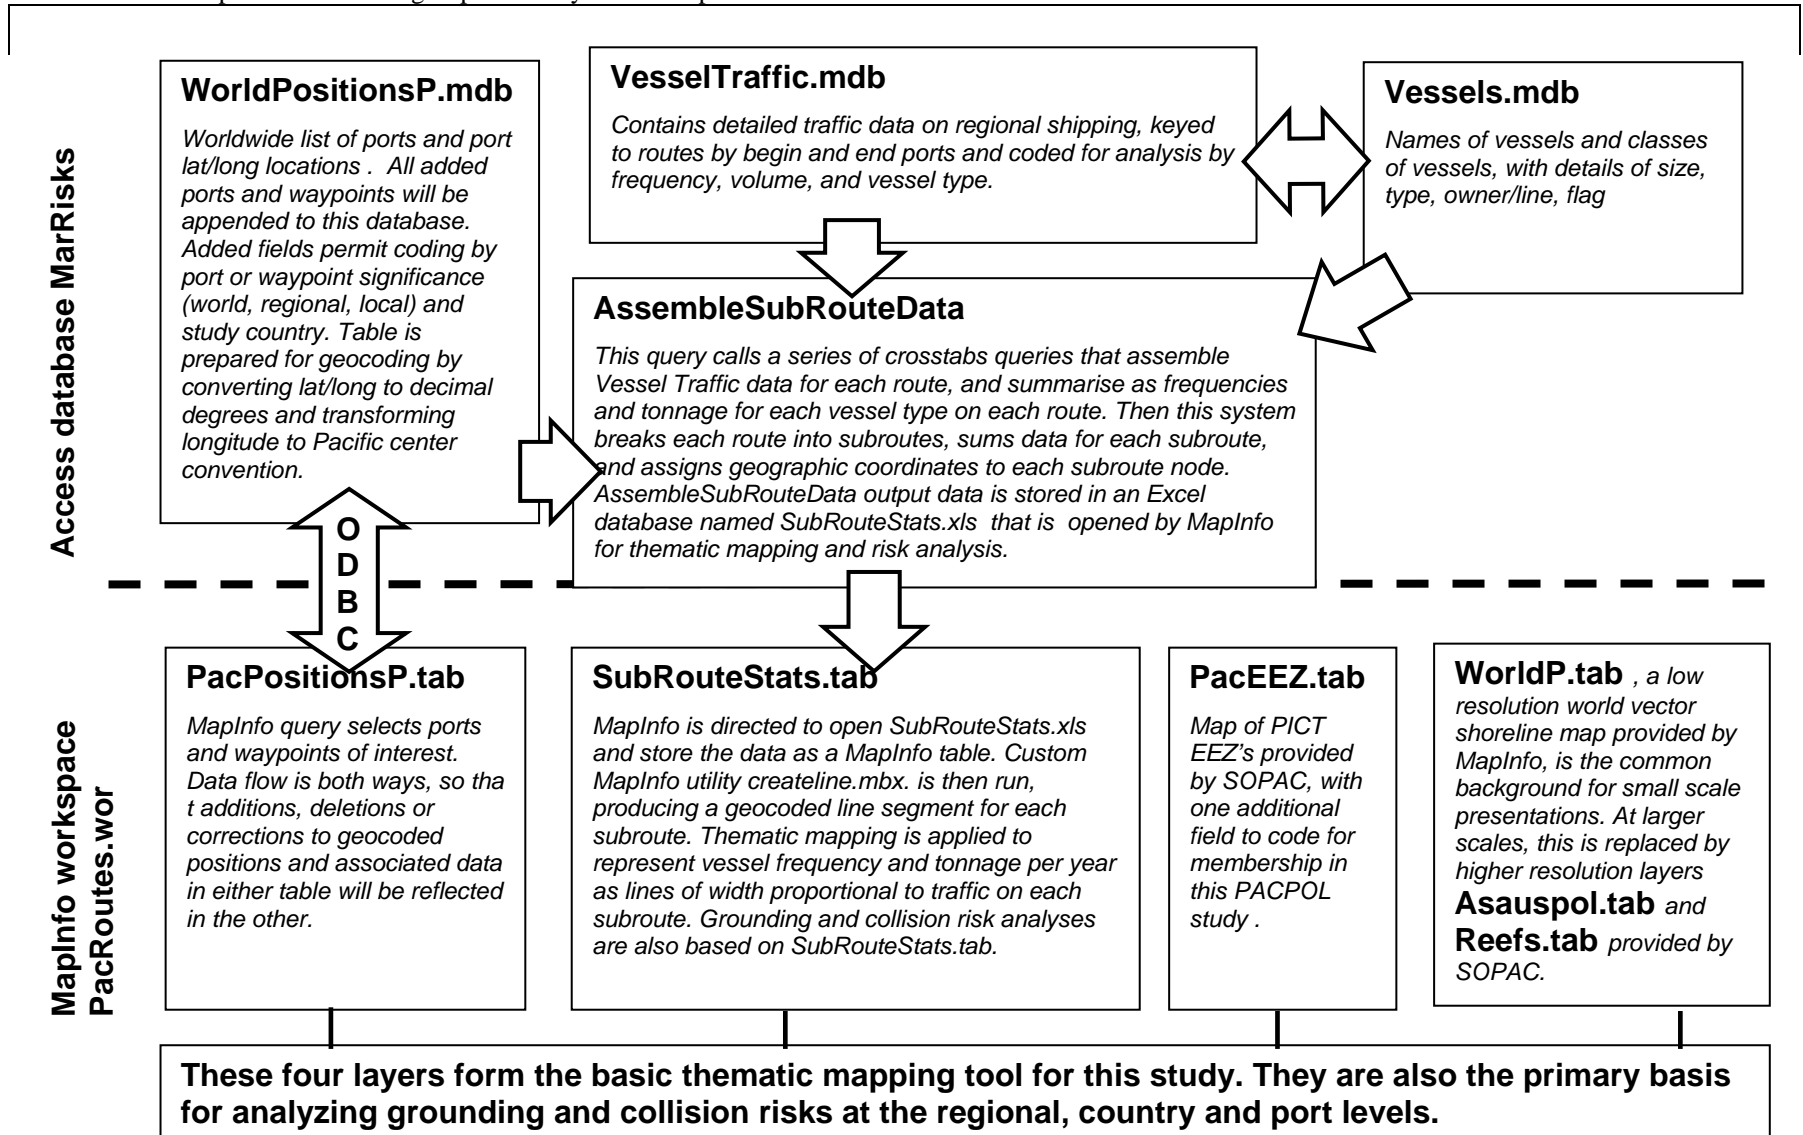
1 APPENDIX 2: Database structure: Access databases and MapInfo GIS

The organizing principle for analysis was that Microsoft Access would be used as far as practical for primary data storage and statistical analysis, with MapInfo GIS for thematic presentations and geospatial analyses of risk potential.

Access database MarRisks

Casualties.mdb
Database of PICT region marine incidents, prepared for MapInfo geocoding in Pacific-centered convention. Casualties contains information from previous "Ship Groundings ..." SPREP report, updated by reference to Lloyd's Casualty Archive and country reports
