SAMOA TSUNAMI

Preliminary Survey

Report on Bulky

Wastes & Sewage Conditions

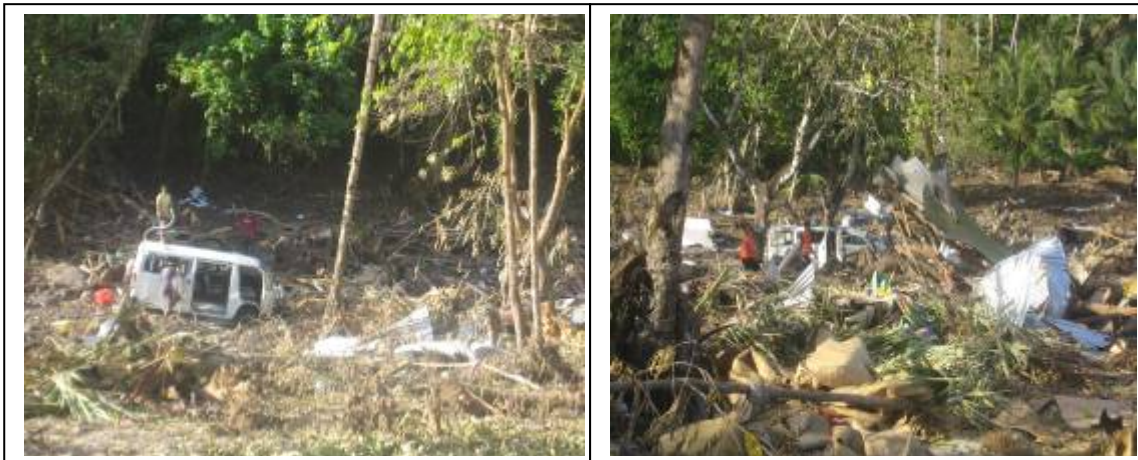
Some Damaged Vehicles have been removed from the sites by their owners and rental businesses

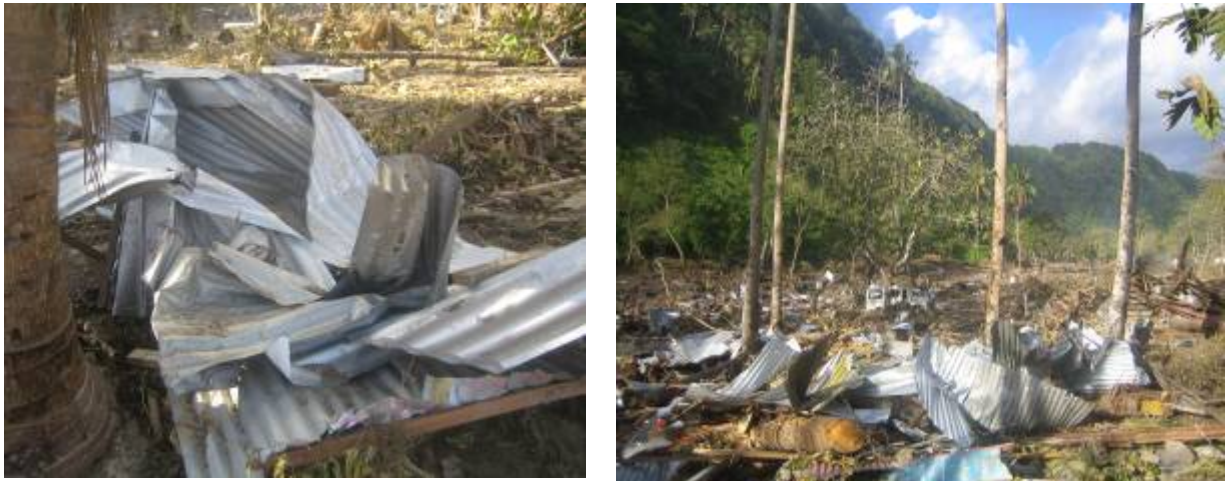
The iron roofing materials were the main bulky waste item observed and noticeable throughout the affected areas. The study estimated about 1,580 cubic-meters of damaged and torn iron roofing materials, with more believed to be buried underground at villages' backyards. These are preliminary findings only due to the amount of wastes which the survey could not identify unless some excavation works conducted on site to dig up the rest of the buried materials.

General conditions of Iron Roofing Materials at the affected areas

- The incorporation of the services provided by Private Recycling Companies will be important in effectively providing separate collection services for large recyclable waste materials such as car bodies, iron roofing materials and others.

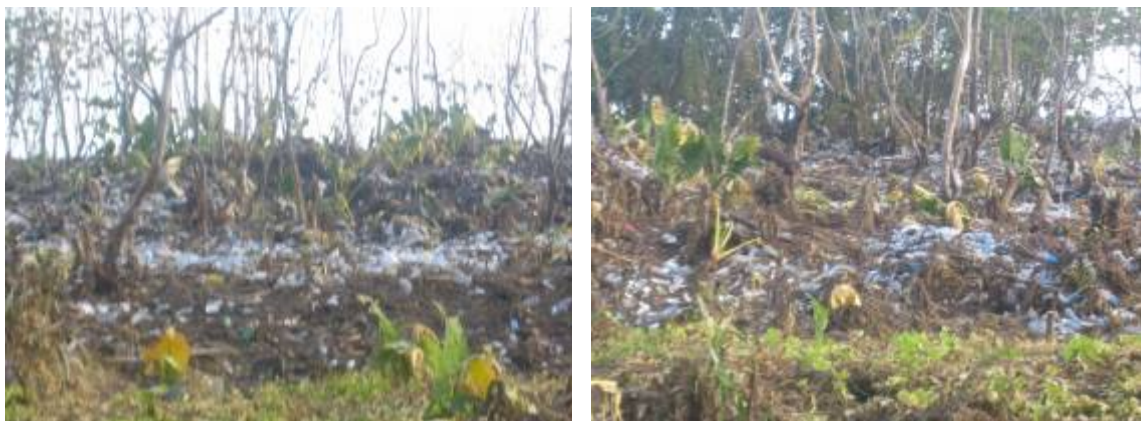
Plastic items being deposited along the road at Lalomanu Village (Tuialamu area)

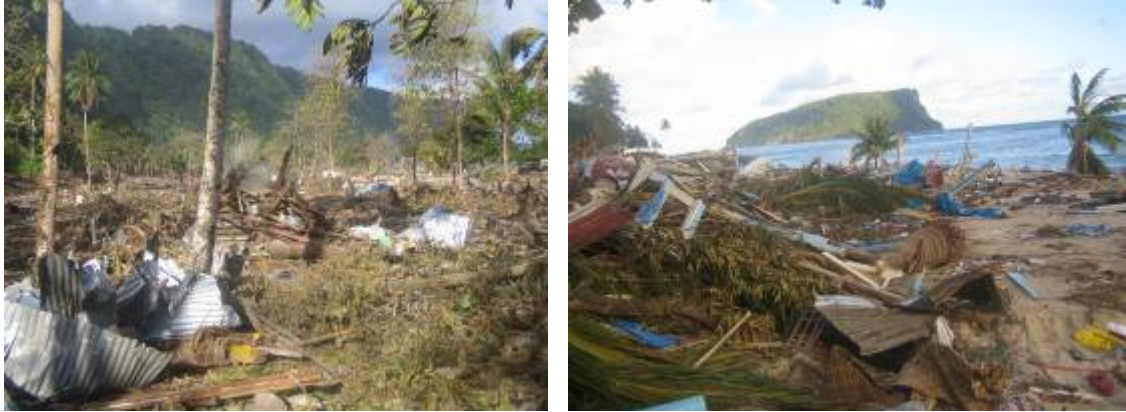
The generated general solid waste mixed with iron metals and timber

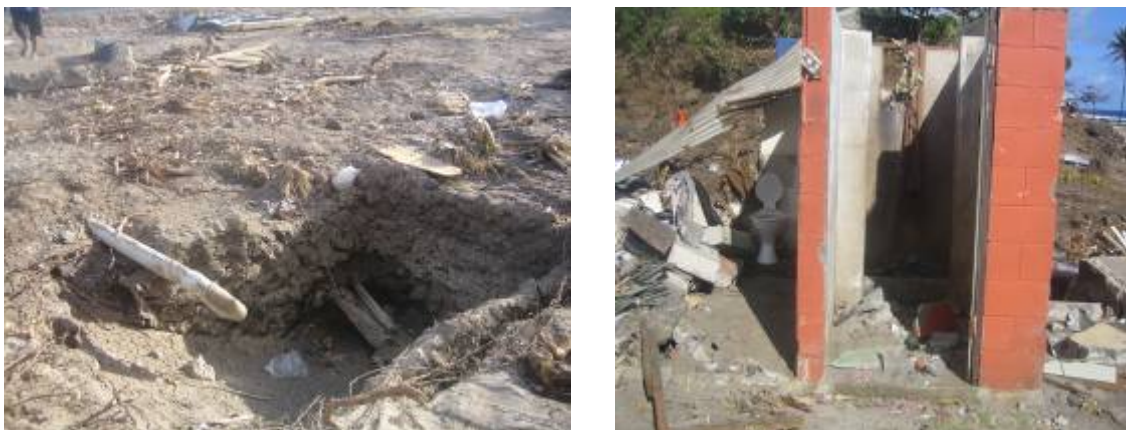
The general conditions of toilets and septic tanks at the affected villages

Most septic tanks have been damaged and their contents have been swept away by waves living open ditches. The partly damaged septic tanks have some sludge contents containing mixed active and stable sludge. This could pose health risks to the affected residences living in the areas if no appropriate actions are taken accordingly.

- The collection of sewage and sludge from damaged toilets and septic tanks shall be the responsibility of the residences with some assistance from the government to reduce the services costs involved. Arrangements can be made with Sewage Disposal Trucks Operators for cheaper rates affordable to the residences. The damaged septic tanks should be considered in future relief reconstruction works.

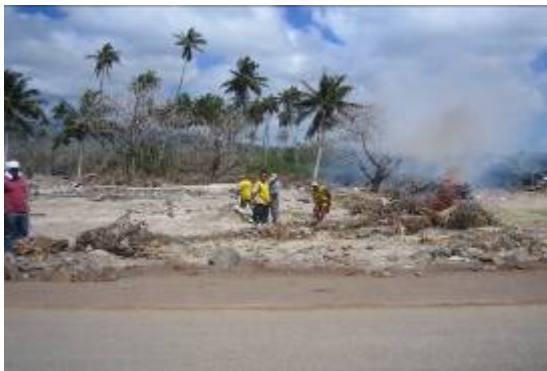
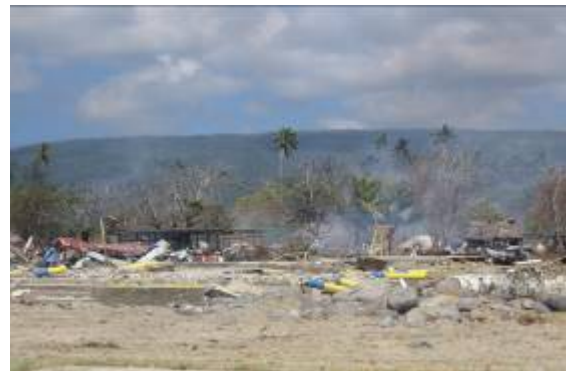
All the wastes collected under the current government rubbish collection program have to be transported and disposed of at the Tafaigata Waste Disposal Site. This includes the collected sewages and sludge from septic tanks. Some villages are planning to use the generated waste to reclaim some eroded lands during the tsunami. There are high quantities of waste deposited in swampy areas and the possibility of these wastes being left there is high given the costs and difficulties involved in removing them. At the time of this assessment, a number of residences were observed burning their piles of garbage because of the bad odour generated.
