MEKONG RIVER BANK PROTECTION IN VIENTIANE

PURPOSE

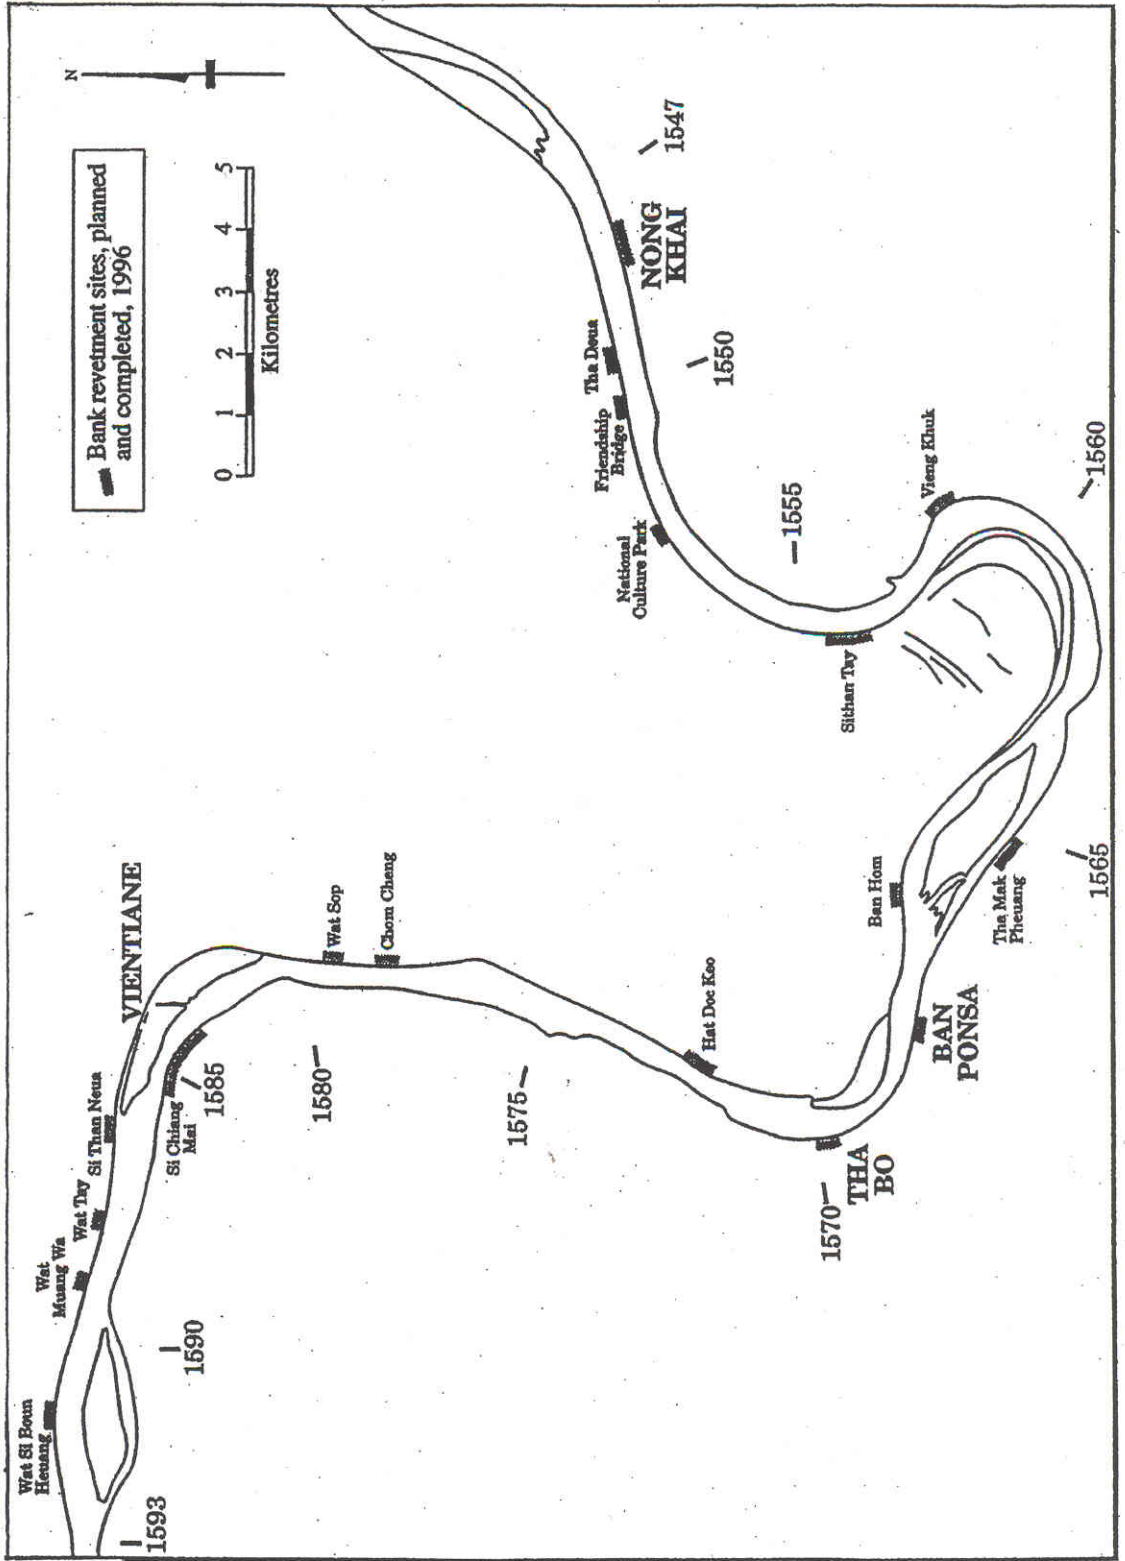
Figure 1 Planned and completed bank revetment sites in the Mekong River near Vientiane.

Bank revetment is considered to be the best available engineering response to the serious river bank erosion occurring along the Mekong River in and around Vientiane. To date, approximately 2.5 km of revetment works have been undertaken at Kaolieo, Sibounheuang, Muangwa, Wattay, Watsop, Ban Hatdokkeo, the National Culture Park, and Thadeua with foreign technical assistance and funding (Figure 1). At Thadeua, for instance, bank protection has been completed along a 250 metre section of the river bank. Although alternative bank protection methods are currently being researched (e.g., the Japan International Cooperation Agency [JICA] is investigating the potential of special grass planting methods in stabilizing river banks), proven technologies still predominate. The 15 m high wall constructed at Thadeua involved extensive slope cutting and the combination of rock-filled mattresses and gambion walls (Note: technical design and construction details are provided in the attached reference readings).
