SPREP/Topic Review 19

POLLUTION SOURCES SURVEY OF THE KINGDOM OF TONGA

South Pacific Commission
Noumea, New Caledonia
November 1984

Richard H. Chesher, Ph.D.

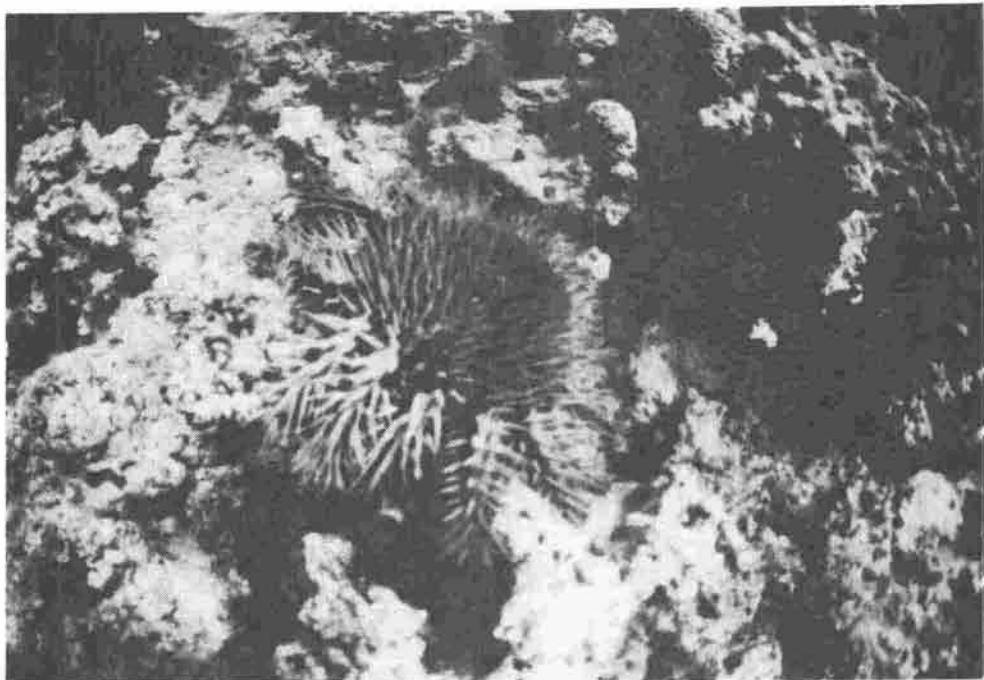
Figure 9. *Acanthaster planci*, the Crown of Thorns starfish eating coral at the edge of a damaged coral reef.

53. In addition, the battered, infected corals and increasing areas of dead reef tends to force coral predators into smaller areas of live coral. Thus I observed coral colonies with huge numbers of predatory snails, and a large population of crown-of-thorns (*Acanthaster planci*, fig. 9) and Cushion (*Culcita* sp.) starfish.

54. As these coral predators are forced together they experience increased breeding success as well as decreased predation from their predators (which are collected for food or sale) and their populations increase (Chesher, 1969).

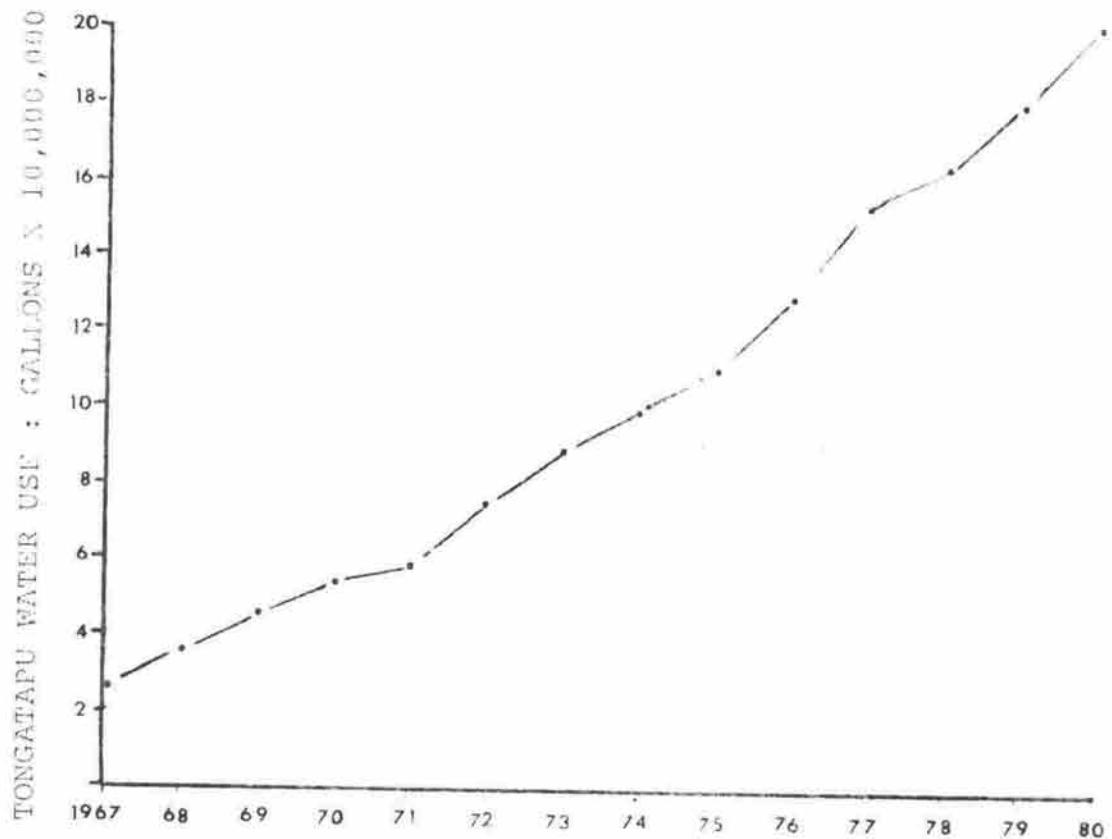
Figure 11. Increase in fresh water use on Tongatapu.

89. Figure 11 shows the increased water use by the people of Tongatapu over the past 13 years. The problems associated with water recharging and the possible increase of contamination of the water lens with increased flushing rates is a subject of great concern.

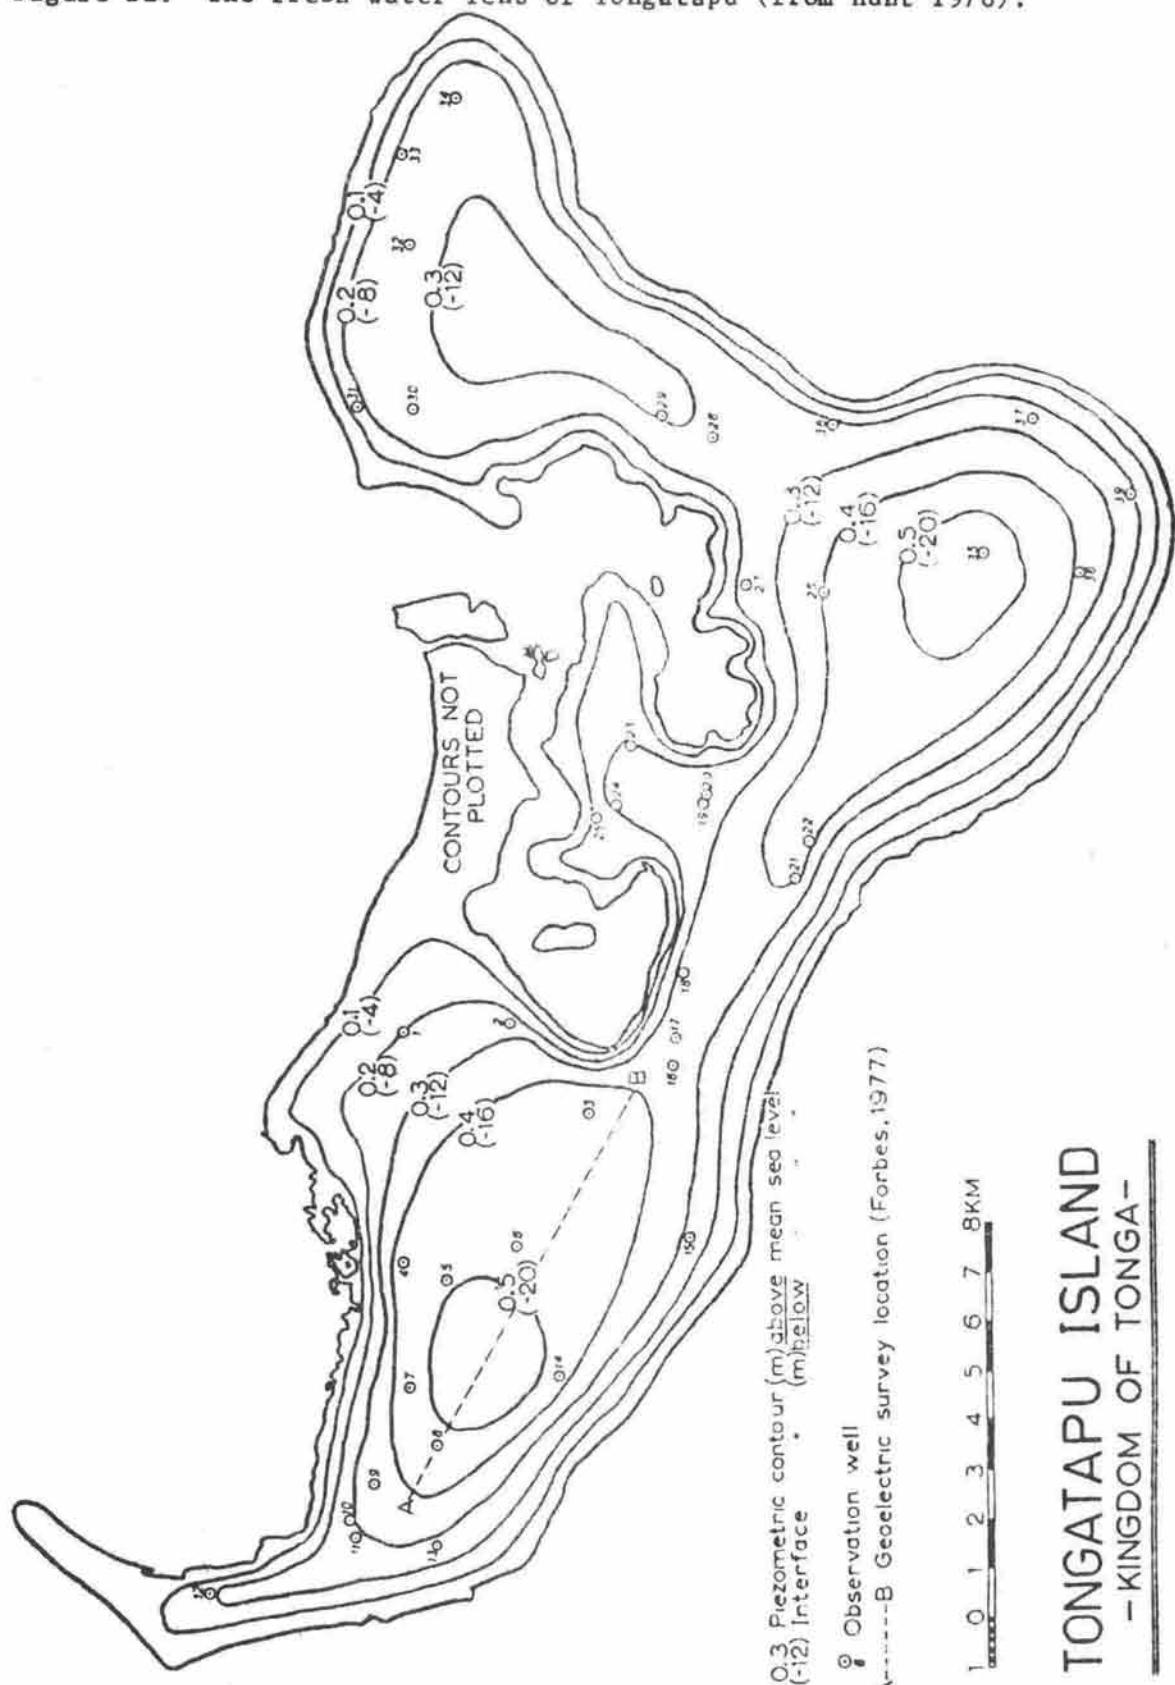
Figure 12. The fresh water lens of Tongatapu (from Hunt 1978).

Measured piezometric contours, observation well locations and calculated interface contours.

90. Poisoning of the watertable with pesticides or their residues is a considerable risk. The water lens of Tongatapu (Figure 12) underlies agricultural areas and while the depth contours of the water lens seem deep enough in the central areas of the island to filter out the pesticides there are areas on the edge of the aquifer and perhaps rock outcroppings through which water containing pesticide residues could reach the drinking water. The more water soluble compounds may even move directly into the aquifer through the soil.

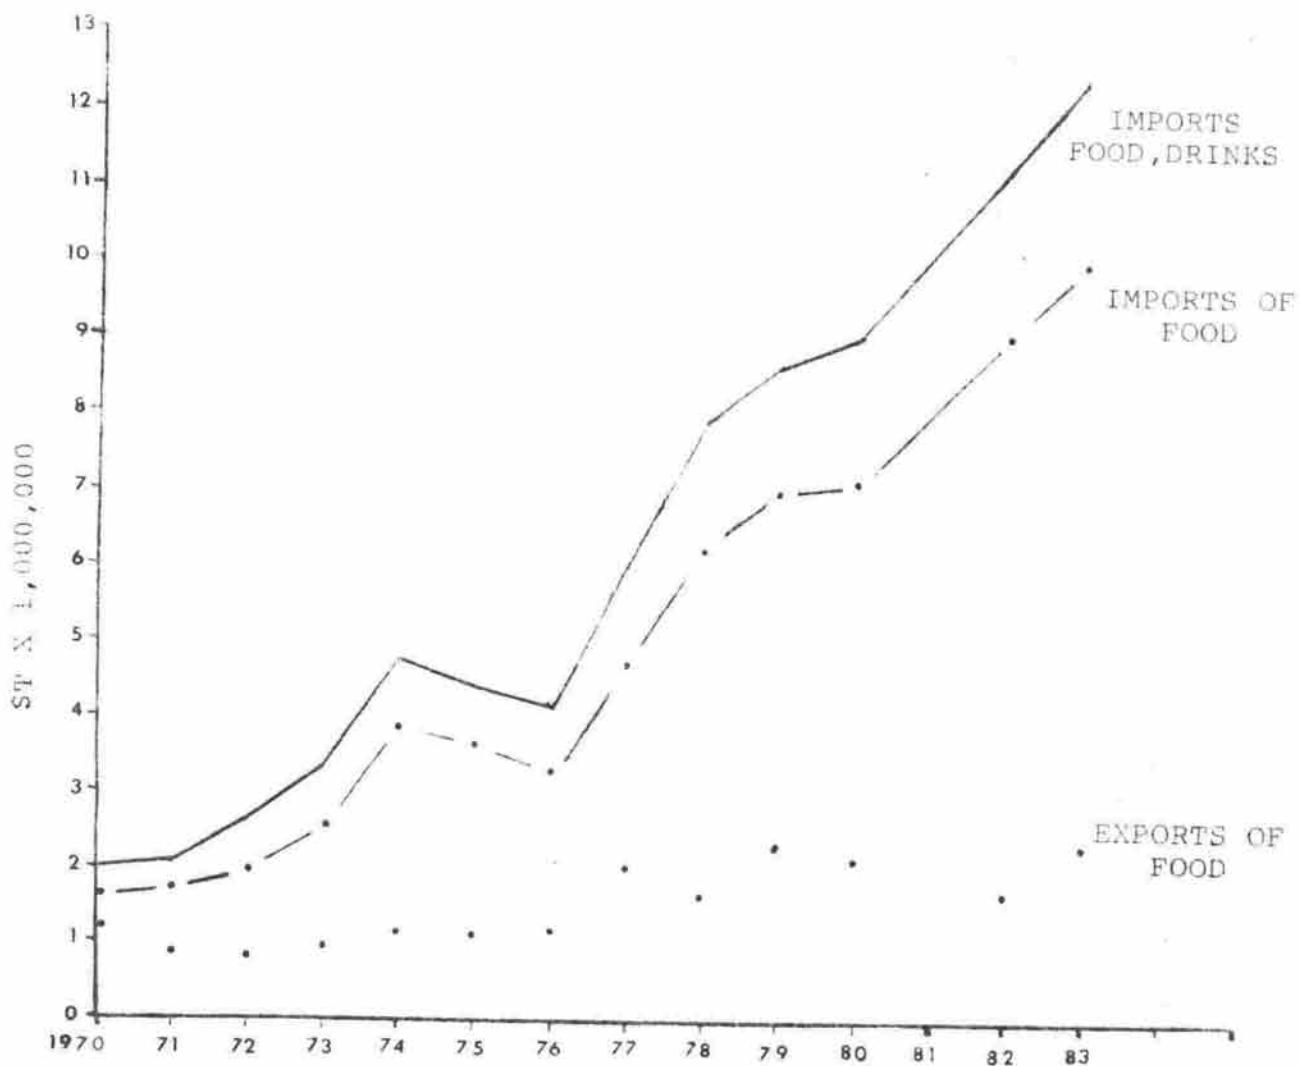
Figure 14. Compare the increase in imported food to exports of food. Economically as well as ecologically, growing nutritional food for local use is better. Vegetables grown for local consumption in small mixed gardens need less pesticides and are better suited to organic farming.

100. Figure 14 shows that the export value of agricultural products is falling far below the increasing cost of importing food to Tonga. This clearly demonstrates the increasing value of Tonga's Garden land for nutritional cropping.

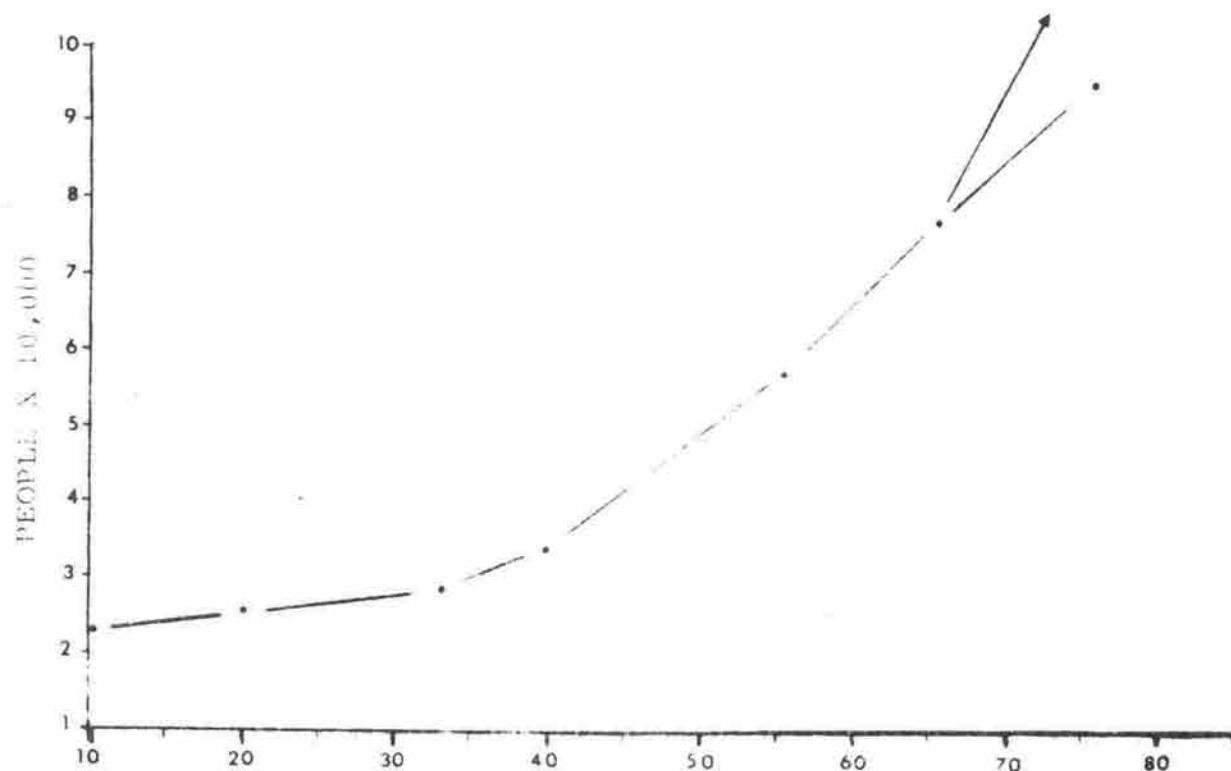
Figure 15. The graph of the population increase in Tonga is identical to a graph of the need for additional land for food production, living space, and support services. The arrow leading upwards from 1966 represents the true population growth. Migration of Tongans to other countries results in the number of people counted in the 1976 Census.

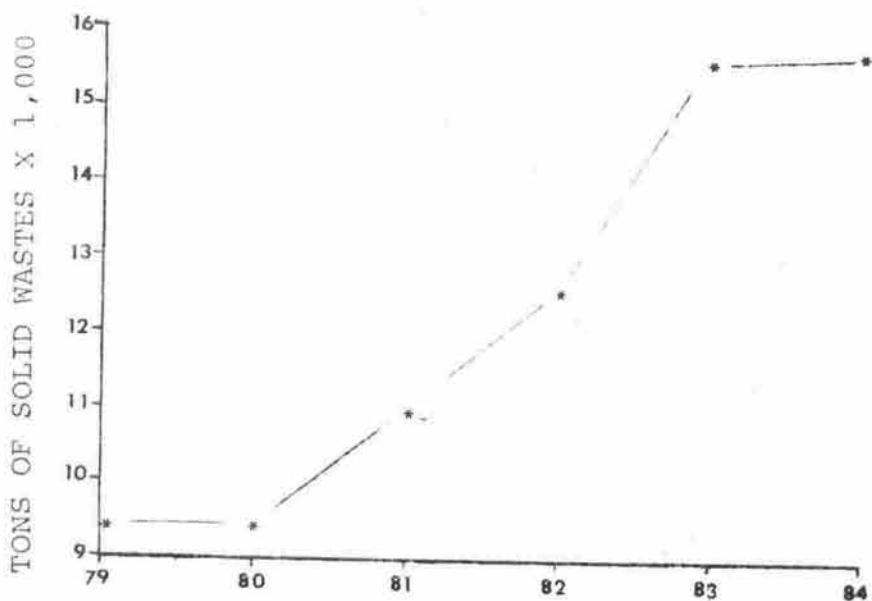
Figure 16. Increase of solid wastes in Tongatapu.

131. Tongatapu has more of a problem as urban dwellers have little opportunity to dispose of wastes and also buy more prepackaged products and imported items which result in solid wastes. Figure 16 shows the increase of solid wastes in Tongatapu in the past few years. As imported goods increase, the residual solid wastes will also increase. Locally produced goods and drinks do not generate toxic or accumulative solid wastes. Non-biodegradeable or toxic wastes are all imported (at great cost).

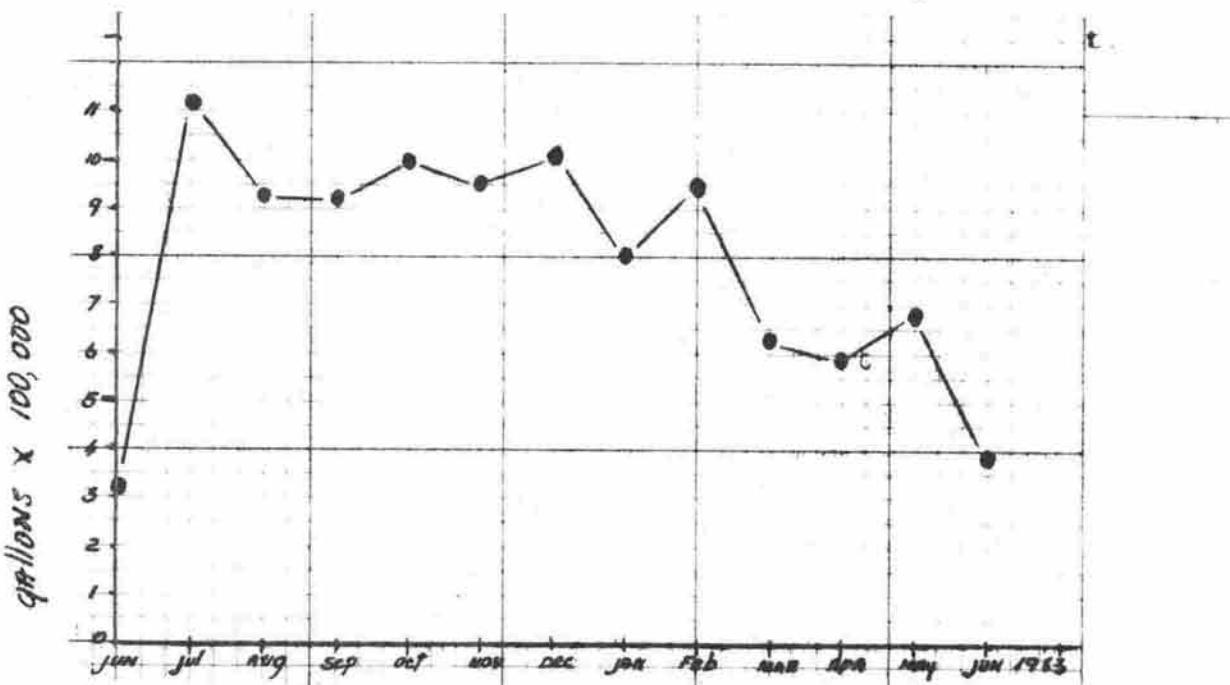
MONTHLY WATER USE OF THE DATELINE HOTEL 1983-84

32. The discharge pipe originally extended to the reef edge but has been broken and discharges onto the reef flat itself. Samples from the pipe showed no chlorine ions and coloform bacteria counts higher than could be counted.

SAMPLE OF EFFLUENT SHOWS NO CHLORINE
COLIFORM BACTERIA TOO NUMEROUS TO COUNT.

RECOMMENDATION 2: Put signs surrounding the reef area between Yellow Pier and the Vuna Wharf written in Tongan indicating the water is polluted and forbidding swimming or fishing or washing of food in the water. Repair and activate the chlorinator on the septic tank storage tank. Build appropriate drainage fields for the septic tanks.

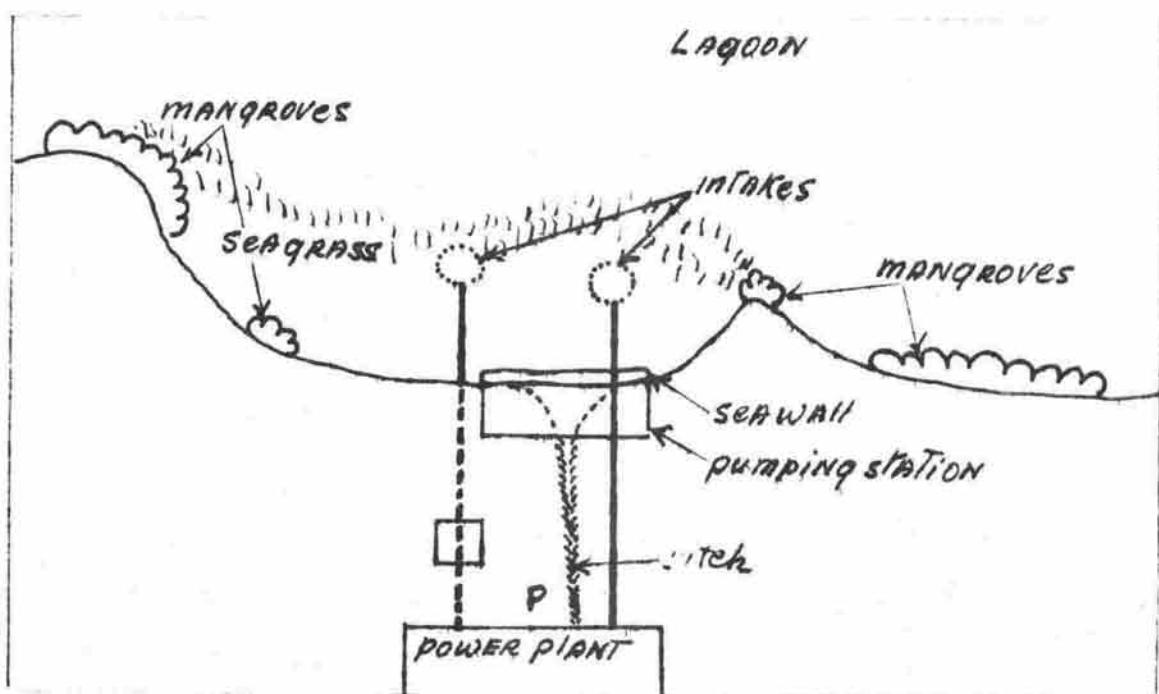
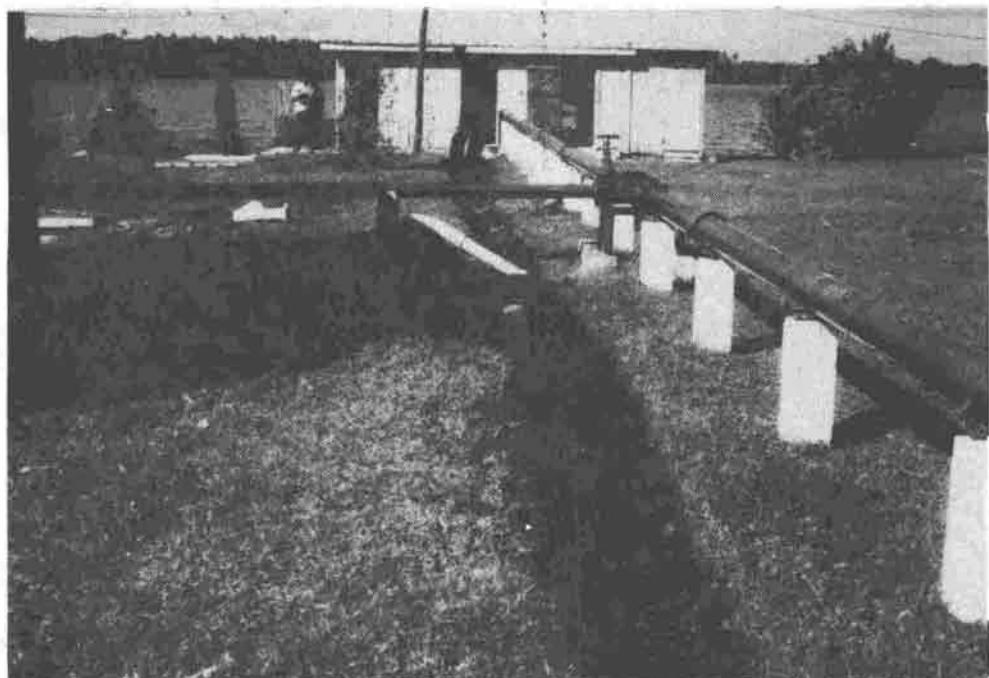
STATION NUMBER 801 MAP REF Tongatapu

(Indicate: Wind Direction, North, Currents, Wave Action)
P=Photograph taken from here, arrow shows angle of viewTYPE OF WASTE oil and soap FROM power plant floor
AMOUNT OF WASTE UNKNOWN
PERIODIC DANGERS large spill of oil and cleaning solutionDILUTION AT DISCHARGE POINT Good: Fair: Poor: X
Comments:BIOLOGICAL AND PHYSICAL CONDITIONS OF RECEIVING WATER:
sea grass and mangroves shallow water lagoon

RECOMMENDATION 22: Stop discharging oil and detergent from the Popua Power Plant into the lagoon during cleaning operations.

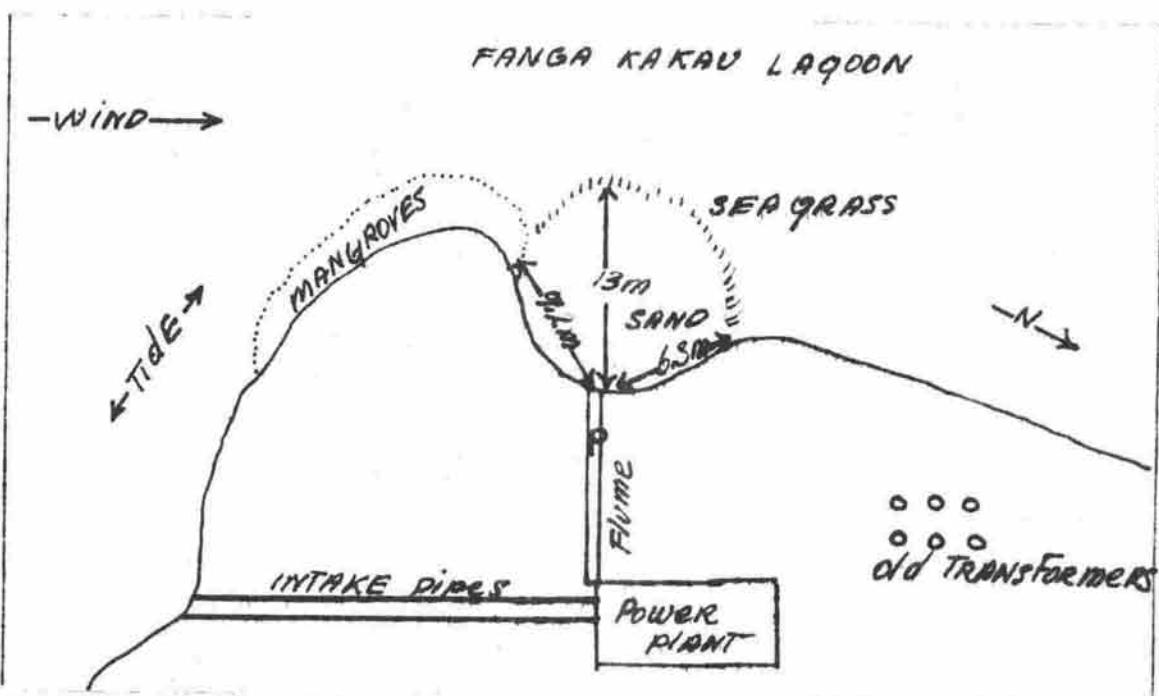
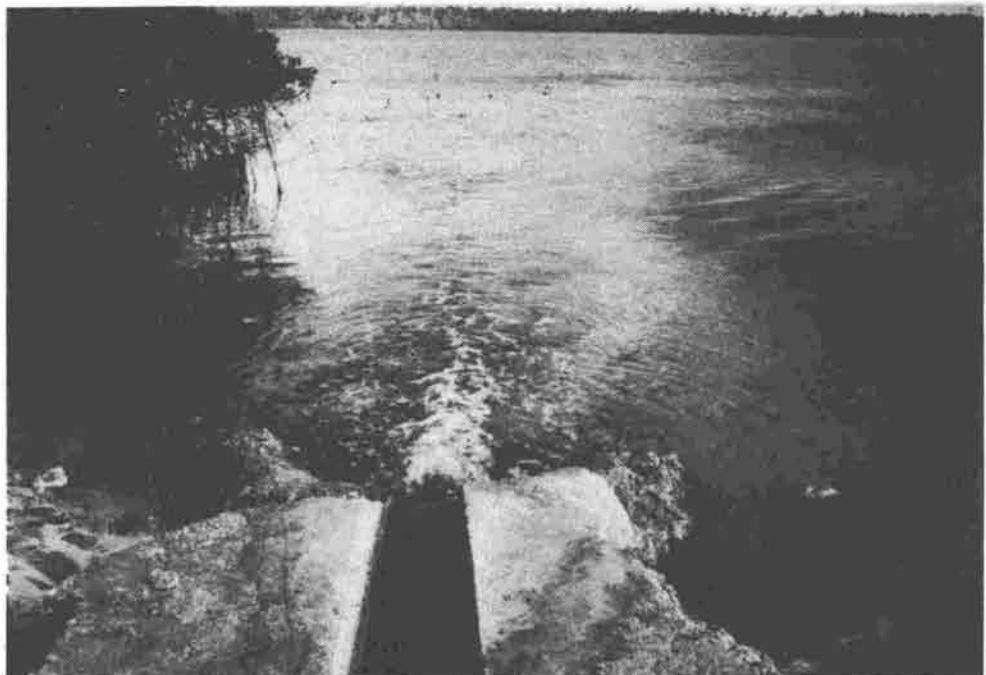
154. The effluent from the power plant empties into a very shallow sea grass bed. The effluent is lagoon water heated through heat exchangers (Data sheet 801 Tongatapu) and carried through an open cement flume back into the lagoon.

TYPE OF WASTE SEA-WATER heated effluent from power plant
